# Access Compliance Report

## Public Rights-of-Way

### (Curb Ramps)

Intersection ID: 27323	Main Street: MEADOW_RUN_LN	Cross Street: THORNHILL_CLUB_DR	Location: SW
ADA ID: 972C5523B26D	Ramp Type: Perp	Initial Pass/Fail: Fail	Overall Compliance: No
		Severity Score: 12.5

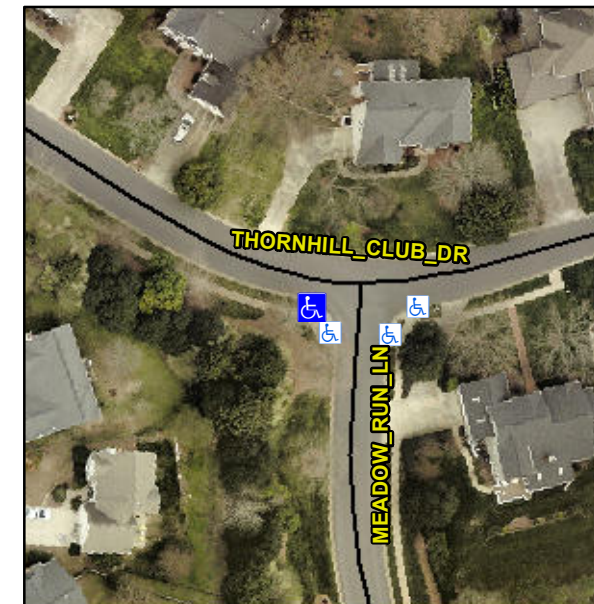
**Not Found, R304.2.2**

Compliance	Description	Data	Compliance	Description	Data
N/A	Ramp Length (in)	109.0	No	Ramp Slope (%)	10.0
Yes	Ramp Width (in)	48.0	Yes	Ramp XSlope (%)	0.8
N/A	Flare Type LT	N/A	N/A	Flare Type RT	N/A
N/A	Flare Slope LT (%)	N/A	N/A	Flare Slope RT (%)	N/A
N/A	Flare Traversable LT?	N/A	N/A	Flare Traversable RT?	N/A
N/A	Landing Length (in)	N/A	N/A	DWS Provided?	N/A
N/A	Landing Width (in)	N/A	N/A	DWS Contrast?	N/A
N/A	Landing Slope (%)	N/A	N/A	DWS Length (in)	N/A
N/A	Landing X Slope (%)	N/A	N/A	DWS Full Width?	N/A
N/A	Landing Curb? (Y/N)	N/A	N/A	DWS Offset (in)	N/A
N/A	Shared Landing?	N/A			
N/A	Gutter Ponding?	N/A	N/A	Gutter Slope (%)	N/A
N/A	Gutter Lip Ht (in)	N/A	N/A	Gutter X Slope (%)	N/A
N/A	Painted X Walk1?	No	N/A	Painted X Walk2?	N/A
	X Walk 1 Direction	To N		X Walk 2 Direction	N/A
N/A	X Walk 1 Width (in)	N/A	N/A	X Walk 2 Width (in)	N/A
	X Walk 1 Slope (%)	3.2		X Walk 2 Slope (%)	N/A
	X Walk 1 X Slope (%)	0.9		X Walk 2 X Slope (%)	N/A

N/A	Ramp inside XWalk1?	N/A	N/A	Ramp inside XWalk2?	N/A
	Road Slope (%)	N/A	N/A	Clear Space?	N/A
	Road X Slope (%)	N/A	N/A	Clear Space to XWalk (in)	N/A
N/A	Any Obstructions?	N/A	N/A	Storm Grate/Utility Hazard?	N/A
	Obstruction Type			Storm Grate/Utility Type	
		N/A			N/A
			Yes	Surface Condition? (G/P)	Good

**Remove & Replace Entire Ramp.**

Total Cost: \$ 1850.00
