Access Compliance Report

Public Rights-of-Way

(Curb Ramps)

Intersection ID: 50587	Main Street: DOWNY_BIRCH_RD	Cross Street: GREAT_LAUREL_RD	Location: NE
ADA ID: 97382F24C862	Ramp Type: Perp	Initial Pass/Fail: Fail	Overall Compliance: No
Severity Score: 10			
Codes/Mitigation Info/Possible Solution		Field Measurements/Component Compliance

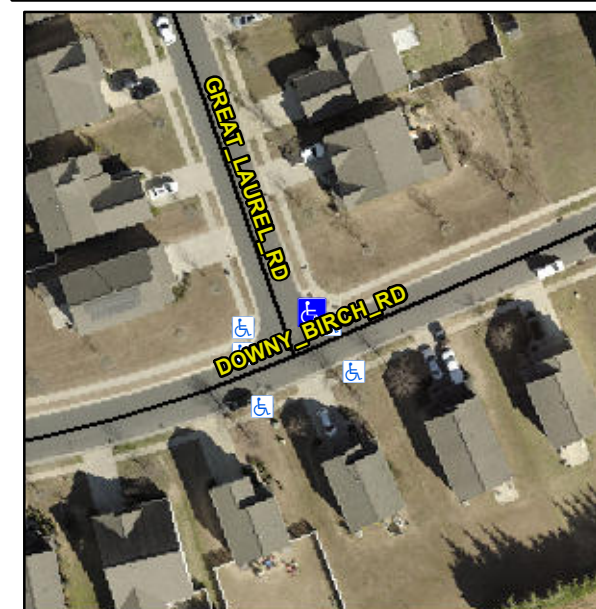
Not Found, R304.5.1, R304.5.3

Compliance	Description	Data	Compliance	Description	Data
N/A	Ramp Length (in)	49.5	Yes	Ramp Slope (%)	6.0
No	Ramp Width (in)	46.5	No	Ramp XSlope (%)	4.8
N/A	Flare Type LT	N/A	N/A	Flare Type RT	N/A
N/A	Flare Slope LT (%)	N/A	N/A	Flare Slope RT (%)	N/A
N/A	Flare Traversable LT?	N/A	N/A	Flare Traversable RT?	N/A
N/A	Landing Length (in)	N/A	N/A	DWS Provided?	N/A
N/A	Landing Width (in)	N/A	N/A	DWS Contrast?	N/A
N/A	Landing Slope (%)	N/A	N/A	DWS Length (in)	N/A
N/A	Landing X Slope (%)	N/A	N/A	DWS Full Width?	N/A
N/A	Landing Curb? (Y/N)	N/A	N/A	DWS Offset (in)	N/A
N/A	Shared Landing?	N/A			
N/A	Gutter Ponding?	N/A	N/A	Gutter Slope (%)	N/A
N/A	Gutter Lip Ht (in)	N/A	N/A	Gutter X Slope (%)	N/A
N/A	Painted X Walk1?	No	N/A	Painted X Walk2?	N/A
	X Walk 1 Direction	To W		X Walk 2 Direction	N/A
N/A	X Walk 1 Width (in)	N/A	N/A	X Walk 2 Width (in)	N/A
	X Walk 1 Slope (%)	0.1		X Walk 2 Slope (%)	N/A
	X Walk 1 X Slope (%)	3.3		X Walk 2 X Slope (%)	N/A

N/A	Ramp inside XWalk1?	N/A	N/A	Ramp inside XWalk2?	N/A
	Road Slope (%)	N/A	N/A	Clear Space?	N/A
	Road X Slope (%)	N/A	N/A	Clear Space to XWalk (in)	N/A
N/A	Any Obstructions?	N/A	N/A	Storm Grate/Utility Hazard?	N/A
	Obstruction Type			Storm Grate/Utility Type	
		N/A			N/A
			Yes	Surface Condition? (G/P)	Good

Remove & Replace Entire Ramp.
