## Access Compliance Report Public Rights-of-Way (Curb Ramps)

Intersection ID: 10040845Main Street: WAKEFIELD\_DRCross Street: N/ALocation:WADA ID: 9749A082CD5ARamp Type: PerpInitial Pass/Fail: FailOverall Compliance: NoSeverity Score:25

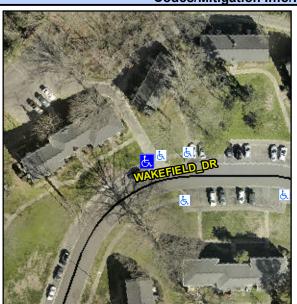
Field Measurements/Component Compliance						
Comp	liance Description	Data	Comp	liance Description	Data	
N/A	Ramp Length (in)	82.0	No	Ramp Slope (%)	9.4	
es/	Ramp Width (in)	48.0	No	Ramp XSlope (%)	5.6	
N/A	Flare Type LT	N/A	N/A	Flare Type RT	N/A	
N/A	Flare Slope LT (%)	N/A	N/A	Flare Slope RT (%)	N/A	
N/A	Flare Traversable LT?	N/A	N/A	Flare Traversable RT?	N/A	
N/A	Landing Length (in)	N/A	N/A	DWS Provided?	N/A	
N/A	Landing Width (in)	N/A	N/A	DWS Contrast?	N/A	
N/A	Landing Slope (%)	N/A	N/A	DWS Length (in)	N/A	
N/A	Landing X Slope (%)	N/A	N/A	DWS Full Width?	N/A	
N/A	Landing Curb? (Y/N)	N/A	N/A	DWS Offset (in)	N/A	
N/A	Shared Landing?	N/A				
N/A	Gutter Ponding?	N/A	N/A	Gutter Slope (%)	N/A	
N/A	Gutter Lip Ht (in)	N/A	N/A	Gutter X Slope (%)	N/A	
N/A	Painted X Walk1?	No	N/A	Painted X Walk2?	N/A	
	X Walk 1 Direction	To W		X Walk 2 Direction	N/A	
N/A	X Walk 1 Width (in)	N/A	N/A	X Walk 2 Width (in)	N/A	
	X Walk 1 Slope (%)	8.0		X Walk 2 Slope (%)	N/A

X Walk 1 X Slope (%)	6.8		X Walk 2 X Slope (%)	N/A	
N/A	Ramp inside XWalk1?	N/A	N/A	Ramp inside XWalk2?	N/A	
	Road Slope (%)	N/A	N/A	Clear Space?	N/A	
	Road X Slope (%)	N/A	N/A	Clear Space to XWalk (in)	N/A	
N/A	Any Obstructions?	N/A	N/A	Storm Grate/Utility Hazard	d? <b>N/A</b>	
	Obstruction Type			Storm Grate/Utility Type		
		N/A			N/A	
			Yes	Surface Condition? (G/P)	Good

Possible Solutions:	9
Remove & Replace Entire Ramp.	N
	Y
	N
	N
	N
	N
Surveyor Notes:	N
N/A	N
i	N
	N
	N
PROW/ADA:	N
Not Found, R304.2.2, R304.5.3	N
	N
	N
	N
