Access Compliance Report

Public Rights-of-Way (Curb Ramps)

Intersection ID: 14970	Main Street: ATHERTON_ST	Cross Street: MARSHALL_PL	Location: SW
ADA ID: 975A0CD76D48	Ramp Type: Perp	Initial Pass/Fail: Fail	Overall Compliance: No
		Severity Score: 1.25

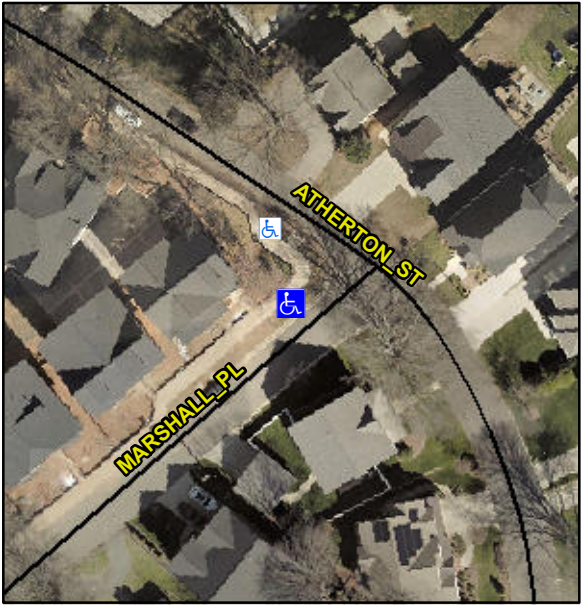
Possible Solutions:		Compliance	Description	Data
	Remove & Replace Entire Ramp.		Yes	Ramp Length (in)	95.5
			N/A	Ramp Width (in)	71.0
			N/A	Flare Type LT	N/A
			N/A	Flare Slope LT (%)	N/A
			N/A	Flare Traversable LT?	N/A
			N/A	Landing Length (in)	N/A
			N/A	Landing Width (in)	N/A
			N/A	Landing Slope (%)	N/A
			N/A	Landing X Slope (%)	N/A
<p>Surveyor Notes:</p> <p>N/A</p> <p>PROW/ADA:</p> <p>R304.5.3</p>			N/A	Flare Type RT	N/A
			N/A	Flare Slope RT (%)	N/A
			N/A	Flare Traversable RT?	N/A
			N/A	DWS Provided?	N/A
			N/A	DWS Contrast?	N/A
			N/A	DWS Length (in)	N/A
			N/A	DWS Full Width?	N/A
			N/A	DWS Offset (in)	N/A
			N/A	Gutter Ponding?	N/A
			N/A	Gutter Lip Ht (in)	N/A
<p>Total Cost:</p> <p>\$ 1850.00</p>			No	Painted X Walk1?	N/A
			N/A	X Walk 1 Direction	To SE
			N/A	X Walk 1 Width (in)	N/A
			N/A	X Walk 1 Slope (%)	1.6

N/A	X Walk 1 X Slope (%)	3.4
			N/A	Ramp inside XWalk1?	N/A
			N/A	Road Slope (%)	N/A
			N/A	Road X Slope (%)	N/A
			N/A	Any Obstructions?	N/A
			N/A	Obstruction Type	N/A
			N/A	Clear Space?	N/A
			N/A	Clear Space to XWalk (in)	N/A
			N/A	Storm Grate/Utility Hazard?	N/A
			N/A	Storm Grate/Utility Type	N/A
			Yes	Surface Condition? (G/P)	Good
