Access Compliance Report Public Rights-of-Way (Curb Ramps)

Intersection ID: 12527 Main Street: E_7TH_ST Cross Street: N_DAVIDSON_ST Location: N

ADA ID: 97687FFAE05E Ramp Type: PerpDiag Initial Pass/Fail: Fail Overall Compliance: No Severity Score: 22.5

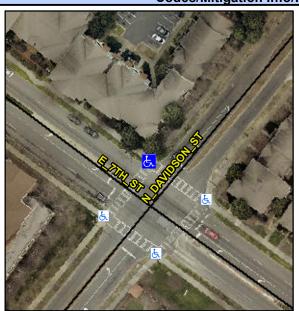
| Compliance Description Data | | Compliance Description | | Data | |
|---|---|---|---|---|---|
| N/A | Ramp Length (in) | 54.0 | No | Ramp Slope (%) | 8.4 |
| No | Ramp Width (in) | 37.5 | Yes | Ramp XSlope (%) | 3.8 |

Remove & Replace Curb Ramp With
Two New Directional Ramps or
Equivalent.

R304.5.1, R304.2.2
