## **Access Compliance Report Public Rights-of-Way** (Curb Ramps)

Intersection ID: 47396 Main Street: FLAT\_RIVER\_DR Cross Street: KENBROOKE\_DR Location: ADA ID: 9775F52B8521 Ramp Type: Perp Initial Pass/Fail: Fail **Overall Compliance: No** Severity Score: 33.75

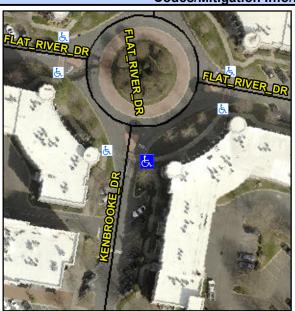
**KENBROOKE DR** Street 1 Name Stop Condition-Street 2 YieldSign Street 2 Name N/A Stop Condition-Street 1 N/A Possible Solutions: Remove & Replace Entire Ramp. Surveyor Notes: N/A PROW/ADA: R304.5.1, R304.2.2

| Field Measurements/Component Compliance | | | | | |
|---|---|---|---|---|---|
| N/A | Ramp Length (in) | 56.0 | No | Ramp Slope (%) | 12.3 |
| No | Ramp Width (in) | 45.5 | Yes | Ramp XSlope (%) | 0.7 |
