Access Compliance Report

Public Rights-of-Way

(Curb Ramps)

Intersection ID: 48955	Main Street: ROYA_PL	Cross Street: DAVID_JENNINGS_AV	Location: NW
ADA ID: 97932819DBE9	Ramp Type: Perp	Initial Pass/Fail: Fail	Overall Compliance: No
			Severity Score: 21.25

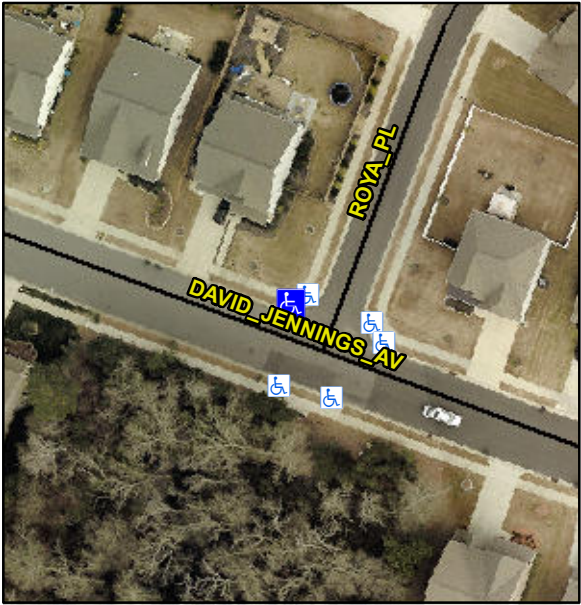
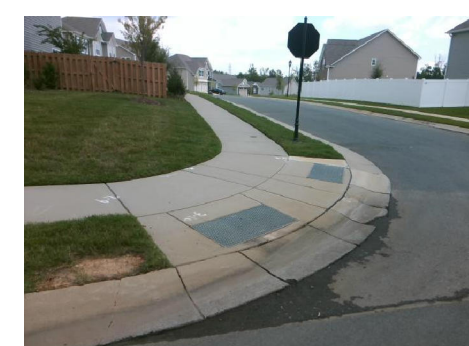
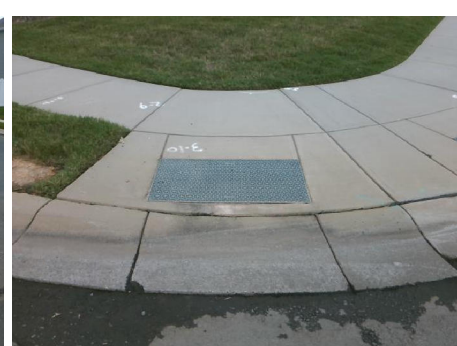
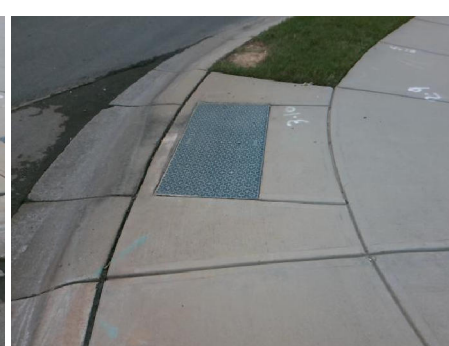
Compliance	Description	Data	Compliance	Description	Data
N/A	Ramp Length (in)	46.5	No	Ramp Slope (%)	8.9
No	Ramp Width (in)	47.5	Yes	Ramp XSlope (%)	1.4
N/A	Flare Type LT	N/A	N/A	Flare Type RT	N/A
N/A	Flare Slope LT (%)	N/A	N/A	Flare Slope RT (%)	N/A
N/A	Flare Traversable LT?	N/A	N/A	Flare Traversable RT?	N/A
N/A	Landing Length (in)	N/A	N/A	DWS Provided?	N/A
N/A	Landing Width (in)	N/A	N/A	DWS Contrast?	N/A
N/A	Landing Slope (%)	N/A	N/A	DWS Length (in)	N/A
N/A	Landing X Slope (%)	N/A	N/A	DWS Full Width?	N/A
N/A	Landing Curb? (Y/N)	N/A	N/A	DWS Offset (in)	N/A
N/A	Shared Landing?	N/A			
N/A	Gutter Ponding?	N/A	N/A	Gutter Slope (%)	N/A
N/A	Gutter Lip Ht (in)	0.5	N/A	Gutter X Slope (%)	N/A
N/A	Painted X Walk1?	No	N/A	Painted X Walk2?	N/A
	X Walk 1 Direction	To SW		X Walk 2 Direction	N/A
N/A	X Walk 1 Width (in)	N/A	N/A	X Walk 2 Width (in)	N/A
	X Walk 1 Slope (%)	5.5		X Walk 2 Slope (%)	N/A
	X Walk 1 X Slope (%)	2.6		X Walk 2 X Slope (%)	N/A

N/A	Ramp inside XWalk1?	N/A	N/A	Ramp inside XWalk2?	N/A
	Road Slope (%)	N/A	N/A	Clear Space?	N/A
	Road X Slope (%)	N/A	N/A	Clear Space to XWalk (in)	N/A
N/A	Any Obstructions?	N/A	N/A	Storm Grate/Utility Hazard?	N/A
	Obstruction Type			Storm Grate/Utility Type	
		N/A			N/A
			Yes	Surface Condition? (G/P)	Good

Possible Solutions:				
	Remove & Replace Entire Ramp.				
	Surveyor Notes:				
	N/A				
	PROW/ADA:				
	Not Found, R304.5.1, R304.2.2				
Street 1 Name	DAVID JENNINGS AV				
Stop Condition-Street 2	None				
Street 2 Name	N/A				
Stop Condition-Street 1	N/A				
Total Cost:		\$	1850.00
