Access Compliance Report

Public Rights-of-Way

(Curb Ramps)

Intersection ID: 18011	Main Street: PARK_RD	Cross Street: HEATHER_LN	Location: NW
ADA ID: 9793DEF24D88	Ramp Type: BlendTrans2	Initial Pass/Fail: Fail	Overall Compliance: No
Codes/Mitigation Info/Possible Solution		Field Measurements/Component Compliance	
Severity Score: 33.75

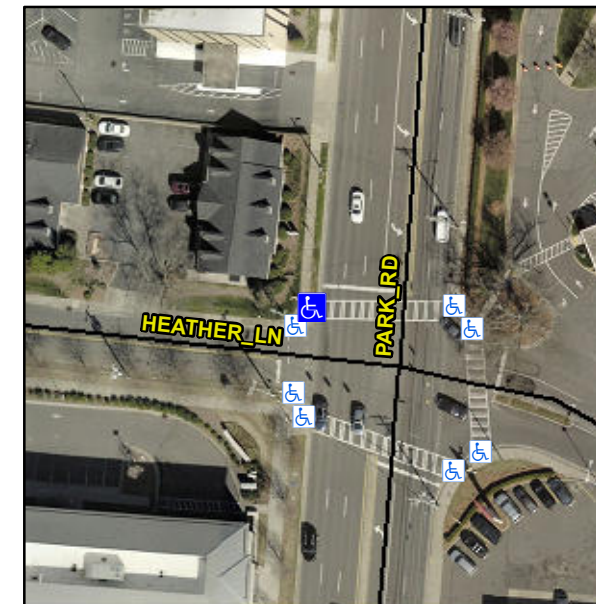
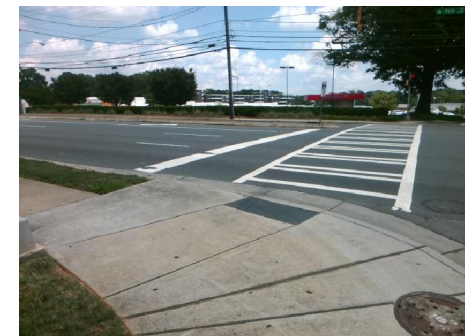
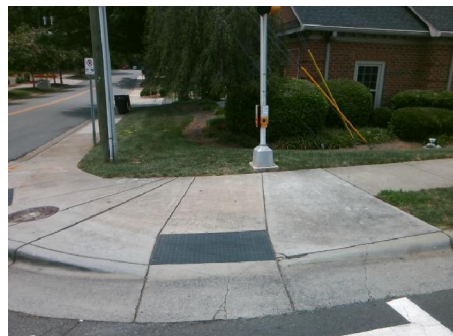
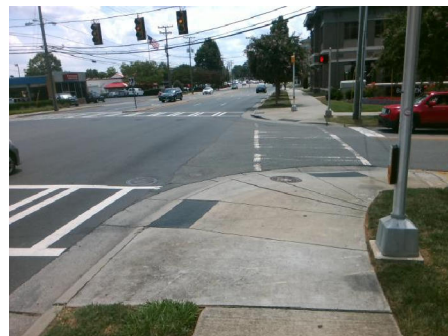
Not Found, R304.5.1, R304.5.3

Compliance	Description	Data	Compliance	Description	Data
N/A	Ramp Length (in)	117.0	Yes	BlendTrans Slope (%)	1.5
No	Ramp Width (in)	46.5	No	BlendTrans XSlope (%)	7.4
N/A	Flare Type LT	N/A	N/A	Flare Type RT	N/A
N/A	Flare Slope LT (%)	N/A	N/A	Flare Slope RT (%)	N/A
N/A	Flare Traversable LT?	N/A	N/A	Flare Traversable RT?	N/A
N/A	Landing Length (in)	N/A	N/A	DWS Provided?	N/A
N/A	Landing Width (in)	N/A	N/A	DWS Contrast?	N/A
N/A	Landing Slope (%)	N/A	N/A	DWS Length (in)	N/A
N/A	Landing X Slope (%)	N/A	N/A	DWS Full Width?	N/A
N/A	Landing Curb? (Y/N)	N/A	N/A	DWS Offset (in)	N/A
N/A	Shared Landing?	N/A			
N/A	Gutter Ponding?	N/A	N/A	Gutter Slope (%)	N/A
N/A	Gutter Lip Ht (in)	N/A	N/A	Gutter X Slope (%)	N/A
N/A	Painted X Walk1?	Yes	N/A	Painted X Walk2?	N/A
	X Walk 1 Direction	To E		X Walk 2 Direction	N/A
	X Walk 1 Width (in)	105.0		X Walk 2 Width (in)	N/A
	X Walk 1 Slope (%)	4.4		X Walk 2 Slope (%)	N/A
	X Walk 1 X Slope (%)	2.4		X Walk 2 X Slope (%)	N/A

N/A	Ramp inside XWalk1?	Yes	N/A	Ramp inside XWalk2?	N/A
	Road Slope (%)	2.4		Clear Space?	N/A
	Road X Slope (%)	4.4	N/A	Clear Space to XWalk (in)	N/A
N/A	Any Obstructions?	N/A	N/A	Storm Grate/Utility Hazard?	N/A
	Obstruction Type			Storm Grate/Utility Type	
		N/A			N/A
			Yes	Surface Condition? (G/P)	Good
			No	Curb Slope (%)	8.5

Remove & Replace Curb Ramp With Two New Directional Ramps or Equivalent.
