## Access Compliance Report Public Rights-of-Way (Curb Ramps)

Intersection ID: 10205Main Street:STATESVILLE\_AVCross Street:OAKLAWN\_AVLocation:SWADA ID: 979C3891C8C2Ramp Type:PerpInitial Pass/Fail:FailOverall Compliance:NoSeverity Score:10

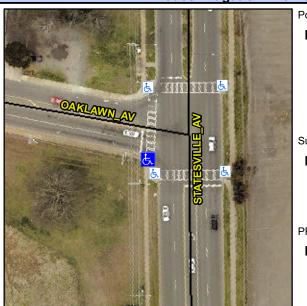
Comp	liance Description	Data	Comp	liance	Description	Data
N/A	Ramp Length (in)	49.0	Yes	Ramp	Slope (%)	7.3
No	Ramp Width (in)	47.5	Yes	Ramp	XSlope (%)	3.2
N/A	Flare Type LT	N/A	N/A	Flare	Type RT	N/A
N/A	Flare Slope LT (%)	N/A	N/A	Flare	Slope RT (%)	N/A
N/A	Flare Traversable LT?	N/A	N/A	Flare	Traversable RT?	N/A
N/A	Landing Length (in)	N/A	N/A	DWS	Provided?	N/A
N/A	Landing Width (in)	N/A	N/A	DWS	Contrast?	N/A
N/A	Landing Slope (%)	N/A	N/A	DWS	Length (in)	N/A
N/A	Landing X Slope (%)	N/A	N/A	DWS	Full Width?	N/A
N/A	Landing Curb? (Y/N)	N/A	N/A	DWS	Offset (in)	N/A
N/A	Shared Landing?	N/A				
N/A	Gutter Ponding?	N/A	N/A	Gutte	r Slope (%)	N/A
N/A	Gutter Lip Ht (in)	N/A	N/A	Gutte	r X Slope (%)	N/A
N/A	Painted X Walk1?	Yes	N/A	Paint	ed X Walk2?	N/A
	X Walk 1 Direction	To N		X Wa	lk 2 Direction	N/A
N/A	X Walk 1 Width (in)	90.5	N/A	X Wa	lk 2 Width (in)	N/A
	X Walk 1 Slope (%)	0.9		X Wa	lk 2 Slope (%)	N/A
	X Walk 1 X Slope (%)	3.2		X Wa	lk 2 X Slope (%)	N/A

N/A	Ramp inside XWalk1?	Yes	N/A	Ram	inside XWalk2?	N/A
	Road Slope (%)	N/A	N/A	Clear	Space?	N/A
	Road X Slope (%)	N/A	N/A	Clear	Space to XWalk (in)	N/A
N/A	Any Obstructions?	N/A	N/A	Storn	n Grate/Utility Hazard?	N/A
	Obstruction Type			Storn	n Grate/Utility Type	
		N/A				N/A
			Yes	Surfa	ce Condition? (G/P)	Good
			Yes	Surfa	ce Condition? (G/P)	C

ossible Solution	
Possible Solutions:	Comp
Remove & Replace Entire Ramp.	N/A
·	No
	N/A
	N/A
	N/A
	N/A
Surveyor Notes:	N/A
N/A	N/A
	N/A
	N/A
	N/A
PROW/ADA:	N/A
Not Found, R304.5.1	N/A
	N/A
	N/A
	N/A
