Access Compliance Report

Public Rights-of-Way

(Curb Ramps)

| Intersection ID: 43477 | Main Street: LIONESS_ST | Cross Street: LIONS_PAW_ST | Location: SW |

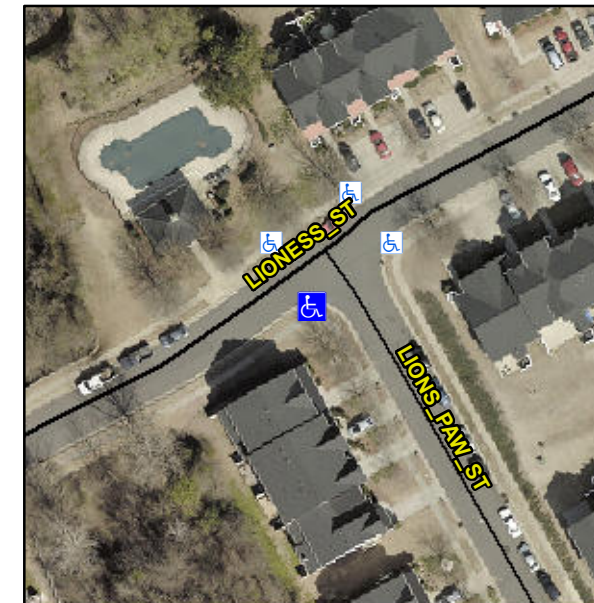
| ADA ID: 97AB82082C2C | Ramp Type: PerpDiag | Initial Pass/Fail: Fail | Overall Compliance: No |
| | | | Severity Score: 21.25 |

Not Found, R304.5.1, R304.5.3

| Compliance | Description | Data | Compliance | Description | Data |
|---|---|---|---|---|---|
| N/A | Ramp Length (in) | 45.0 | Yes | Ramp Slope (%) | 6.5 |
| No | Ramp Width (in) | 46.0 | No | Ramp XSlope (%) | 5.8 |

Remove & Replace Curb Ramp With Two New Directional Ramps or Equivalent.
