# Access Compliance Report

## Public Rights-of-Way

### (Curb Ramps)

Intersection ID: 45198	Main Street: PERENNIAL_TERRACE_DR	Cross Street: W_CRAIGHEAD_RD	Location: SE
ADA ID: 97ADBA62DDEC	Ramp Type: PerpDiag	Initial Pass/Fail: Fail	Overall Compliance: No
Severity Score: 22.5			
Codes/Mitigation Info/Possible Solution		Field Measurements/Component Compliance

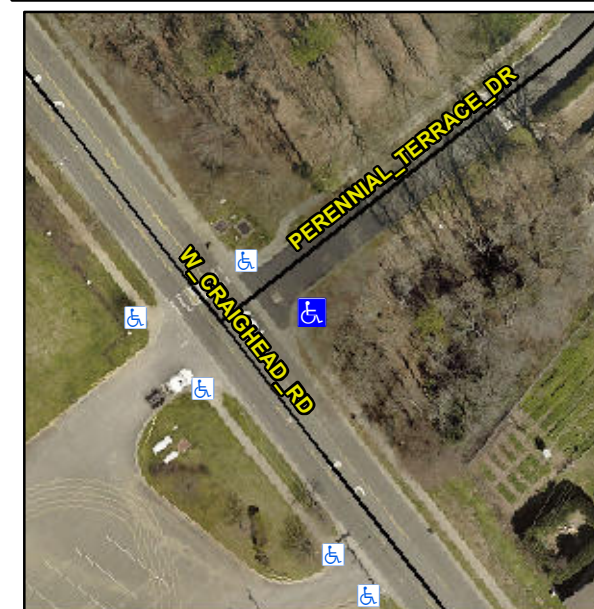
**Not Found, R304.5.1, R304.2.2, R304.5.3**

Compliance	Description	Data	Compliance	Description	Data
N/A	Ramp Length (in)	23.5	No	Ramp Slope (%)	9.4
No	Ramp Width (in)	46.0	No	Ramp XSlope (%)	5.0
N/A	Flare Type LT	N/A	N/A	Flare Type RT	N/A
N/A	Flare Slope LT (%)	N/A	N/A	Flare Slope RT (%)	N/A
N/A	Flare Traversable LT?	N/A	N/A	Flare Traversable RT?	N/A
N/A	Landing Length (in)	N/A	N/A	DWS Provided?	N/A
N/A	Landing Width (in)	N/A	N/A	DWS Contrast?	N/A
N/A	Landing Slope (%)	N/A	N/A	DWS Length (in)	N/A
N/A	Landing X Slope (%)	N/A	N/A	DWS Full Width?	N/A
N/A	Landing Curb? (Y/N)	N/A	N/A	DWS Offset (in)	N/A
N/A	Shared Landing?	N/A			
N/A	Gutter Ponding?	Yes	N/A	Gutter Slope (%)	N/A
N/A	Gutter Lip Ht (in)	0.5	N/A	Gutter X Slope (%)	N/A
N/A	Painted X Walk1?	No	N/A	Painted X Walk2?	No
	X Walk 1 Direction	To NW		X Walk 2 Direction	To SW
N/A	X Walk 1 Width (in)	N/A	N/A	X Walk 2 Width (in)	N/A
	X Walk 1 Slope (%)	1.1		X Walk 2 Slope (%)	0.6
	X Walk 1 X Slope (%)	4.0		X Walk 2 X Slope (%)	1.5

N/A	Ramp inside XWalk1?	N/A	N/A	Ramp inside XWalk2?	N/A
	Road Slope (%)	3.1	N/A	Clear Space?	N/A
	Road X Slope (%)	2.2	N/A	Clear Space to XWalk (in)	N/A
N/A	Any Obstructions?	N/A	N/A	Storm Grate/Utility Hazard?	N/A
	Obstruction Type			Storm Grate/Utility Type	
		N/A			N/A
		Yes		Surface Condition? (G/P)	Good

**Remove & Replace Curb Ramp With Two New Directional Ramps or Equivalent.**
