# Access Compliance Report

## Public Rights-of-Way

### (Curb Ramps)

Intersection ID: 27962	Main Street: PINE_VALLEY_CLUB_DR	Cross Street: ROYAL_ABERDEEN_CT	Location: SE
ADA ID: 97B4E4A34503	Ramp Type: Perp	Initial Pass/Fail: Fail	Overall Compliance: No
Severity Score: 10			
Codes/Mitigation Info/Possible Solution		Field Measurements/Component Compliance

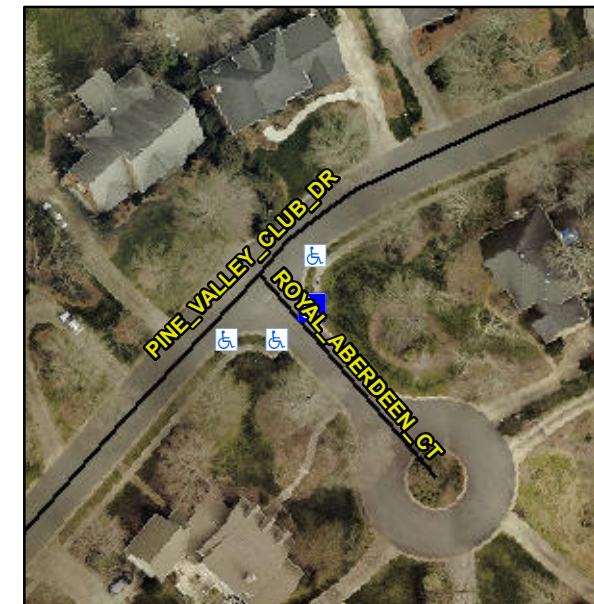
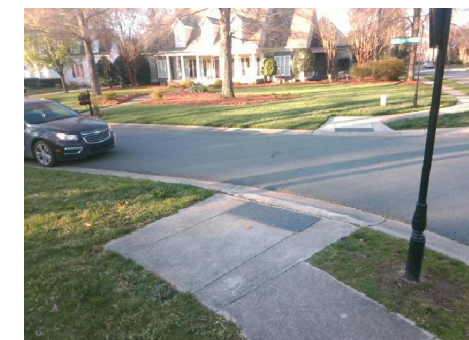
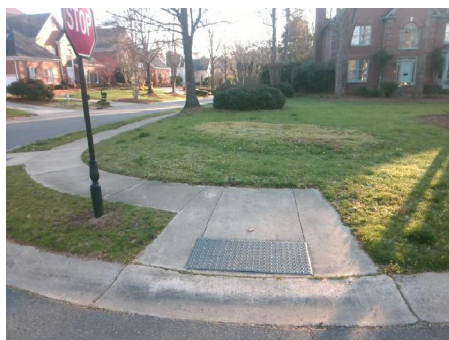
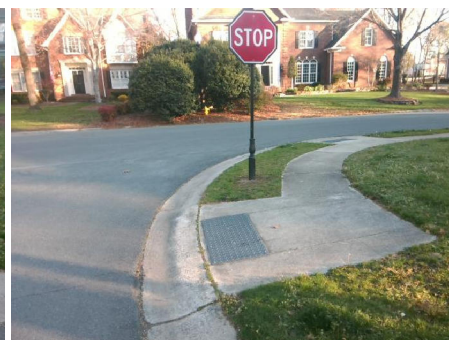
**Not Found, R304.5.1, R304.5.3**

Compliance	Description	Data	Compliance	Description	Data
N/A	Ramp Length (in)	96.0	Yes	Ramp Slope (%)	6.5
No	Ramp Width (in)	43.0	No	Ramp XSlope (%)	2.3
N/A	Flare Type LT	N/A	N/A	Flare Type RT	N/A
N/A	Flare Slope LT (%)	N/A	N/A	Flare Slope RT (%)	N/A
N/A	Flare Traversable LT?	N/A	N/A	Flare Traversable RT?	N/A
N/A	Landing Length (in)	N/A	N/A	DWS Provided?	N/A
N/A	Landing Width (in)	N/A	N/A	DWS Contrast?	N/A
N/A	Landing Slope (%)	N/A	N/A	DWS Length (in)	N/A
N/A	Landing X Slope (%)	N/A	N/A	DWS Full Width?	N/A
N/A	Landing Curb? (Y/N)	N/A	N/A	DWS Offset (in)	N/A
N/A	Shared Landing?	N/A			
N/A	Gutter Ponding?	N/A	N/A	Gutter Slope (%)	N/A
N/A	Gutter Lip Ht (in)	N/A	N/A	Gutter X Slope (%)	N/A
N/A	Painted X Walk1?	No	N/A	Painted X Walk2?	N/A
	X Walk 1 Direction	To SW		X Walk 2 Direction	N/A
N/A	X Walk 1 Width (in)	N/A	N/A	X Walk 2 Width (in)	N/A
	X Walk 1 Slope (%)	0.2		X Walk 2 Slope (%)	N/A
	X Walk 1 X Slope (%)	0.3		X Walk 2 X Slope (%)	N/A

N/A	Ramp inside XWalk1?	N/A	N/A	Ramp inside XWalk2?	N/A
	Road Slope (%)	N/A	N/A	Clear Space?	N/A
	Road X Slope (%)	N/A	N/A	Clear Space to XWalk (in)	N/A
N/A	Any Obstructions?	N/A	N/A	Storm Grate/Utility Hazard?	N/A
	Obstruction Type			Storm Grate/Utility Type	
		N/A			N/A
			Yes	Surface Condition? (G/P)	Good

**Remove & Replace Entire Ramp.**

Total Cost: \$ 1850.00
