Access Compliance Report Public Rights-of-Way (Curb Ramps)

| Intersection ID: 27628 | Main Street: BALLANTYNE_COMMONS_PY Cross Street: ADAIR_MANOR_CT | | | | | | | Location: | NW |
| ADA ID: 97C2A70A1A10 | 10 Ramp Type: Perp | | | | Initial Pass/Fail: Fail Overall Compliance: No | | | | 12.5 |

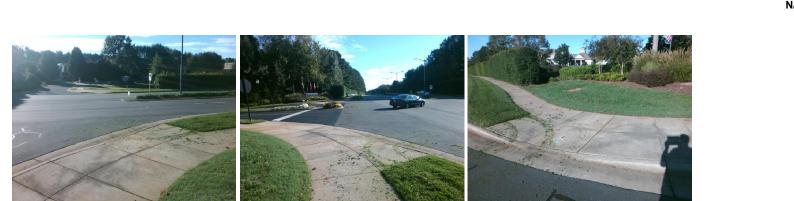
| Intersection ID: 27628 | Main Street: BALLANTYNE_COMMONS_PY Cross Street: ADAIR_MANOR_CT | | | | | | | Location: | NW |
|---|---|---|---|---|---|---|---|---|---|
| a second of a second second | area and | Remove & Replace Entire Ra | mp. | N/A | Ramp Length (in) | 112.0 | Yes | Ramp Slope (%) | 6.8 |
| CULUE CONTRACT | | · · · · | • | Yes | Ramp Width (in) | 54.0 | No | Ramp XSlope (%) | 6.0 |
| | SI I | Not Found, R304.5.3 | | N/A | Gutter Lip Ht (in) | N/A | N/A | Gutter X Slope (%) | N/A |

| Intersection ID: 27628 | Main Street: BALLANTYNE_COMMONS_PY Cross Street: ADAIR_MANOR_CT | | | | | | | Location: | NW |
|---|---|---|---|---|---|---|---|---|---|
| | | Total Cost: \$ | 1850.00 | | Obstruction Type | | | Storm Grate/Utility Type | |
