Access Compliance Report

Public Rights-of-Way

(Curb Ramps)

Intersection ID: 17250	Main Street: CROYDON_RD	Cross Street: QUEENS_RD_WEST	Location: NE
ADA ID: 97CF174619D0	Ramp Type: Perp	Initial Pass/Fail: Fail	Overall Compliance: No
		Severity Score: 1.25

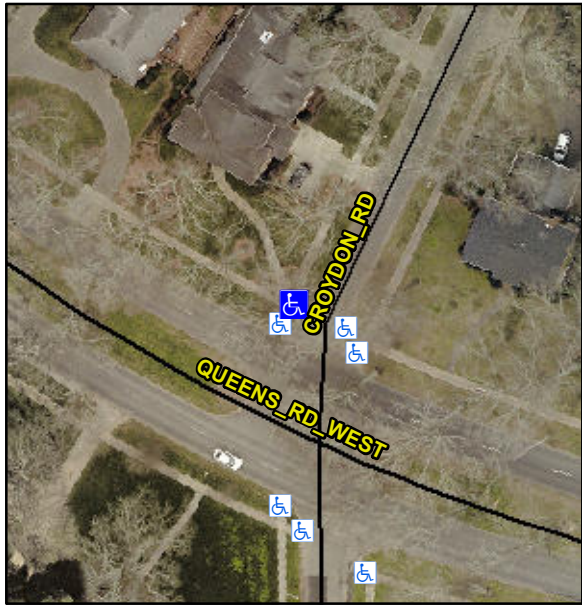
Possible Solutions:		Compliance	Description	Data	Compliance	Description	Data
	Remove & Replace Entire Ramp.		N/A	Ramp Length (in)	88.0	Yes	Ramp Slope (%)	6.8
			Yes	Ramp Width (in)	61.0	No	Ramp XSlope (%)	2.8
			N/A	Flare Type LT	N/A	N/A	Flare Type RT	N/A
			N/A	Flare Slope LT (%)	N/A	N/A	Flare Slope RT (%)	N/A
			N/A	Flare Traversable LT?	N/A	N/A	Flare Traversable RT?	N/A
			N/A	Landing Length (in)	N/A	N/A	DWS Provided?	N/A
			N/A	Landing Width (in)	N/A	N/A	DWS Contrast?	N/A
			N/A	Landing Slope (%)	N/A	N/A	DWS Length (in)	N/A
			N/A	Landing X Slope (%)	N/A	N/A	DWS Full Width?	N/A
Surveyor Notes:			N/A	Landing Curb? (Y/N)	N/A	N/A	DWS Offset (in)	N/A
N/A			N/A	Shared Landing?	N/A			
PROW/ADA:			N/A	Gutter Ponding?	N/A	N/A	Gutter Slope (%)	N/A
Not Found, R304.5.3			N/A	Gutter Lip Ht (in)	N/A	N/A	Gutter X Slope (%)	N/A

N/A	Painted X Walk1?	No	N/A	Painted X Walk2?	N/A
				X Walk 1 Direction	To SE		X Walk 2 Direction	N/A
			N/A	X Walk 1 Width (in)	N/A	N/A	X Walk 2 Width (in)	N/A
				X Walk 1 Slope (%)	4.6		X Walk 2 Slope (%)	N/A
				X Walk 1 X Slope (%)	0.5		X Walk 2 X Slope (%)	N/A
			N/A	Ramp inside XWalk1?	N/A	N/A	Ramp inside XWalk2?	N/A
				Road Slope (%)	N/A	N/A	Clear Space?	N/A
				Road X Slope (%)	N/A	N/A	Clear Space to XWalk (in)	N/A
			N/A	Any Obstructions?	N/A	N/A	Storm Grate/Utility Hazard?	N/A
				Obstruction Type			Storm Grate/Utility Type	
					N/A			N/A
						Yes	Surface Condition? (G/P)	Good
