Access Compliance Report

Public Rights-of-Way

(Curb Ramps)

Intersection ID: 23717	Main Street: E WESTINGHOUSE BV	Cross Street: CHINA GROVE CHURCH RD	Location: SW
ADA ID: 97DDCA503A70	Ramp Type: PerpDiag	Initial Pass/Fail: Fail	Overall Compliance: No
Codes/Mitigation Info/Possible Solution		Field Measurements/Component Compliance

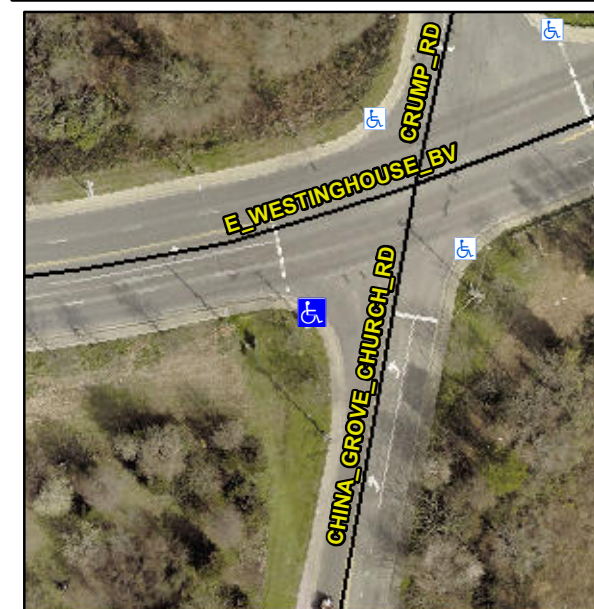
Not Found, R304.2.2

Compliance	Description	Data	Compliance	Description	Data
N/A	Ramp Length (in)	62.0	No	Ramp Slope (%)	10.7
Yes	Ramp Width (in)	48.0	Yes	Ramp XSlope (%)	2.5
N/A	Flare Type LT	N/A	N/A	Flare Type RT	N/A
N/A	Flare Slope LT (%)	N/A	N/A	Flare Slope RT (%)	N/A
N/A	Flare Traversable LT?	N/A	N/A	Flare Traversable RT?	N/A
N/A	Landing Length (in)	N/A	N/A	DWS Provided?	N/A
N/A	Landing Width (in)	N/A	N/A	DWS Contrast?	N/A
N/A	Landing Slope (%)	N/A	N/A	DWS Length (in)	N/A
N/A	Landing X Slope (%)	N/A	N/A	DWS Full Width?	N/A
N/A	Landing Curb? (Y/N)	N/A	N/A	DWS Offset (in)	N/A
N/A	Shared Landing?	N/A			
N/A	Gutter Ponding?	N/A	N/A	Gutter Slope (%)	N/A
N/A	Gutter Lip Ht (in)	N/A	N/A	Gutter X Slope (%)	N/A
N/A	Painted X Walk1?	No	N/A	Painted X Walk2?	No
	X Walk 1 Direction	To NE		X Walk 2 Direction	To NE
N/A	X Walk 1 Width (in)	N/A	N/A	X Walk 2 Width (in)	N/A
	X Walk 1 Slope (%)	5.0		X Walk 2 Slope (%)	1.0
	X Walk 1 X Slope (%)	2.2		X Walk 2 X Slope (%)	3.8

N/A	Ramp inside XWalk1?	N/A	N/A	Ramp inside XWalk2?	N/A
	Road Slope (%)	3.8	N/A	Clear Space?	N/A
	Road X Slope (%)	2.4	N/A	Clear Space to XWalk (in)	N/A
N/A	Any Obstructions?	N/A	N/A	Storm Grate/Utility Hazard?	N/A
	Obstruction Type			Storm Grate/Utility Type	
		N/A			N/A
			Yes	Surface Condition? (G/P)	Good

Remove & Replace Curb Ramp With Two New Directional Ramps or Equivalent.
