# Access Compliance Report

## Public Rights-of-Way

### (Curb Ramps)

| Intersection ID: 12766 | Main Street: S_GRAHAM_ST | Cross Street: W_PALMER_ST | Location: W |

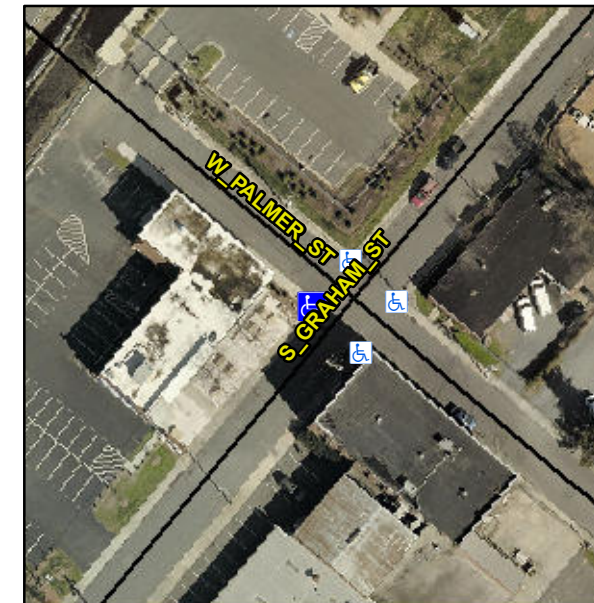
| ADA ID: 97FA11AB0AA3 | Ramp Type: PerpDiag | Initial Pass/Fail: Fail | Overall Compliance: No |
| | | Severity Score: 12.5 | |

**Not Found, R304.5.3**

| Compliance | Description | Data | Compliance | Description | Data |
|---|---|---|---|---|---|
| Yes | Ramp Width (in) | 48.0 | No | Ramp XSlope (%) | 6.5 |

**Remove & Replace Curb Ramp With Two New Directional Ramps or Equivalent.**

Total Cost: \$ 3200.00
