# Access Compliance Report

## Public Rights-of-Way

### (Curb Ramps)

Intersection ID: 3908	Main Street: BULLE ROCK CT	Cross Street: WOODCOCK LN	Location: NE
ADA ID: 980B57A7DC2F	Ramp Type: Perp	Initial Pass/Fail: Fail	Overall Compliance: No
		Severity Score: 22.5

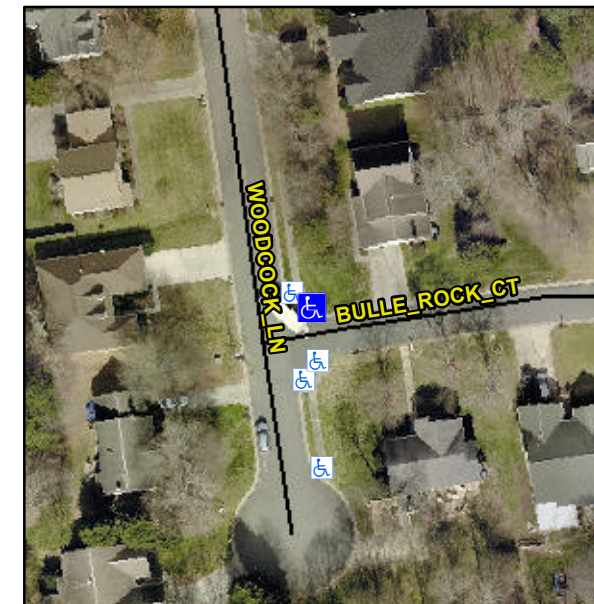
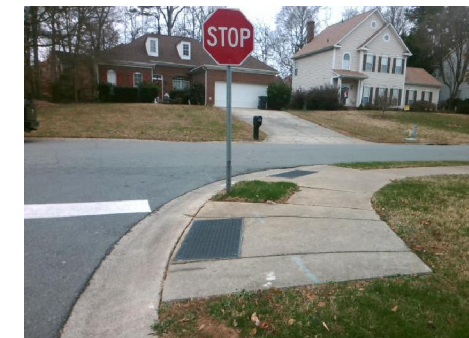
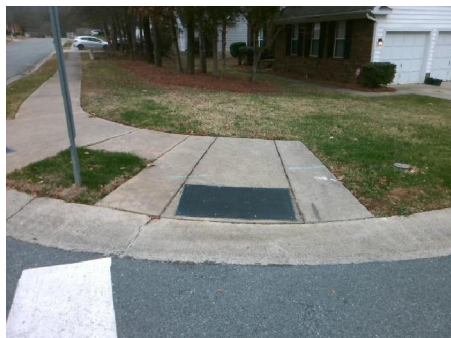
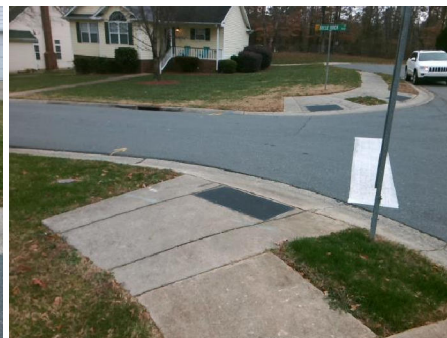
**R304.5.1, R304.2.2, R304.5.3**

Compliance	Description	Data	Compliance	Description	Data
N/A	Ramp Length (in)	46.0	No	Ramp Slope (%)	10.4
No	Ramp Width (in)	44.0	No	Ramp XSlope (%)	4.5
N/A	Flare Type LT	N/A	N/A	Flare Type RT	N/A
N/A	Flare Slope LT (%)	N/A	N/A	Flare Slope RT (%)	N/A
N/A	Flare Traversable LT?	N/A	N/A	Flare Traversable RT?	N/A
N/A	Landing Length (in)	N/A	N/A	DWS Provided?	N/A
N/A	Landing Width (in)	N/A	N/A	DWS Contrast?	N/A
N/A	Landing Slope (%)	N/A	N/A	DWS Length (in)	N/A
N/A	Landing X Slope (%)	N/A	N/A	DWS Full Width?	N/A
N/A	Landing Curb? (Y/N)	N/A	N/A	DWS Offset (in)	N/A
N/A	Shared Landing?	N/A			
N/A	Gutter Ponding?	N/A	N/A	Gutter Slope (%)	N/A
N/A	Gutter Lip Ht (in)	N/A	N/A	Gutter X Slope (%)	N/A
N/A	Painted X Walk1?	No	N/A	Painted X Walk2?	N/A
	X Walk 1 Direction	To S		X Walk 2 Direction	N/A
N/A	X Walk 1 Width (in)	N/A	N/A	X Walk 2 Width (in)	N/A
	X Walk 1 Slope (%)	1.6		X Walk 2 Slope (%)	N/A
	X Walk 1 X Slope (%)	4.4		X Walk 2 X Slope (%)	N/A

N/A	Ramp inside XWalk1?	N/A	N/A	Ramp inside XWalk2?	N/A
	Road Slope (%)	N/A	N/A	Clear Space?	N/A
	Road X Slope (%)	N/A	N/A	Clear Space to XWalk (in)	N/A
N/A	Any Obstructions?	N/A	N/A	Storm Grate/Utility Hazard?	N/A
	Obstruction Type			Storm Grate/Utility Type	
		N/A			N/A
			Yes	Surface Condition? (G/P)	Good

**Remove & Replace Entire Ramp.**

Total Cost: \$ 1850.00
