Access Compliance Report

Public Rights-of-Way

(Curb Ramps)

Intersection ID: 48369	Main Street: WHEATFIELD_RD	Cross Street: TURKEY_HILL_RD	Location: NE
ADA ID: 981E3FB74400	Ramp Type: PerpDiag	Initial Pass/Fail: Fail	Overall Compliance: No
Severity Score: 21.25			
Codes/Mitigation Info/Possible Solution		Field Measurements/Component Compliance

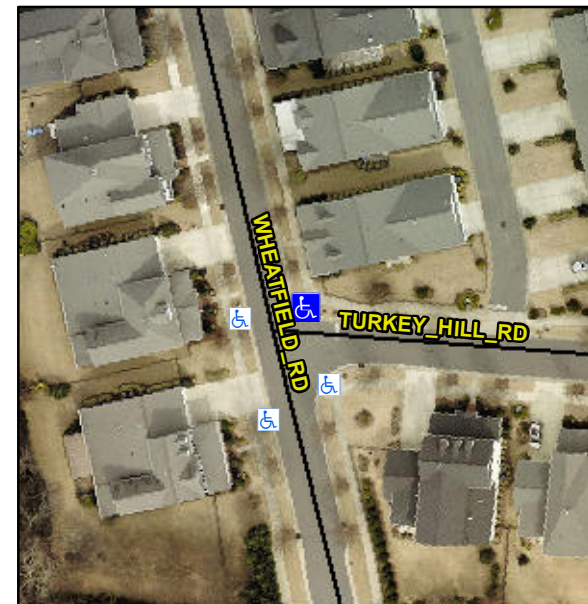
Not Found, R304.5.1, R304.2.2

Compliance	Description	Data	Compliance	Description	Data
N/A	Ramp Length (in)	73.0	No	Ramp Slope (%)	8.6
No	Ramp Width (in)	46.0	Yes	Ramp XSlope (%)	1.0
N/A	Flare Type LT	N/A	N/A	Flare Type RT	N/A
N/A	Flare Slope LT (%)	N/A	N/A	Flare Slope RT (%)	N/A
N/A	Flare Traversable LT?	N/A	N/A	Flare Traversable RT?	N/A
N/A	Landing Length (in)	N/A	N/A	DWS Provided?	N/A
N/A	Landing Width (in)	N/A	N/A	DWS Contrast?	N/A
N/A	Landing Slope (%)	N/A	N/A	DWS Length (in)	N/A
N/A	Landing X Slope (%)	N/A	N/A	DWS Full Width?	N/A
N/A	Landing Curb? (Y/N)	N/A	N/A	DWS Offset (in)	N/A
N/A	Shared Landing?	N/A			
N/A	Gutter Ponding?	N/A	N/A	Gutter Slope (%)	N/A
N/A	Gutter Lip Ht (in)	N/A	N/A	Gutter X Slope (%)	N/A
N/A	Painted X Walk1?	No	N/A	Painted X Walk2?	No
	X Walk 1 Direction	To W		X Walk 2 Direction	To S
N/A	X Walk 1 Width (in)	N/A	N/A	X Walk 2 Width (in)	N/A
	X Walk 1 Slope (%)	1.7		X Walk 2 Slope (%)	0.0
	X Walk 1 X Slope (%)	0.6		X Walk 2 X Slope (%)	0.7

N/A	Ramp inside XWalk1?	N/A	N/A	Ramp inside XWalk2?	N/A
	Road Slope (%)	1.8	N/A	Clear Space?	N/A
	Road X Slope (%)	1.2	N/A	Clear Space to XWalk (in)	N/A
N/A	Any Obstructions?	N/A	N/A	Storm Grate/Utility Hazard?	N/A
	Obstruction Type			Storm Grate/Utility Type	
		N/A			N/A
			Yes	Surface Condition? (G/P)	Good

Remove & Replace Curb Ramp With Two New Directional Ramps or Equivalent.
