Access Compliance Report

Public Rights-of-Way

(Curb Ramps)

Intersection ID: 42727	Main Street: SPEEDWELL_CT	Cross Street: PICKEREL_LN	Location:	N
ADA ID: 98326943E10A	Ramp Type: PerpDiag	Initial Pass/Fail: Fail	Overall Compliance: No	Severity Score: 8.75
Codes/Mitigation Info/Possible Solution		Field Measurements/Component Compliance

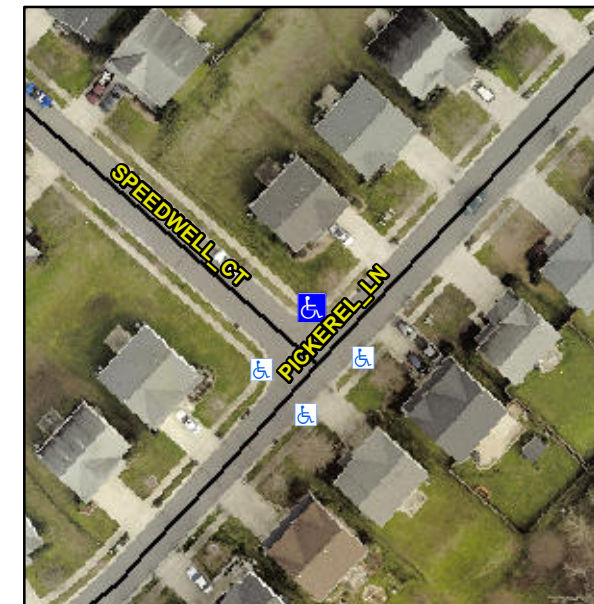
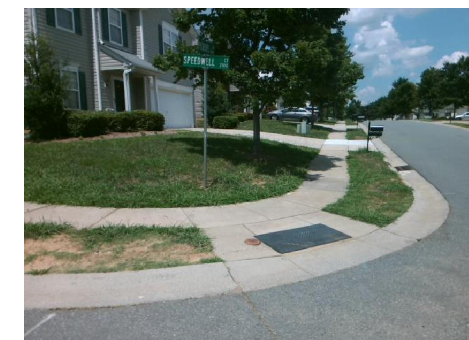
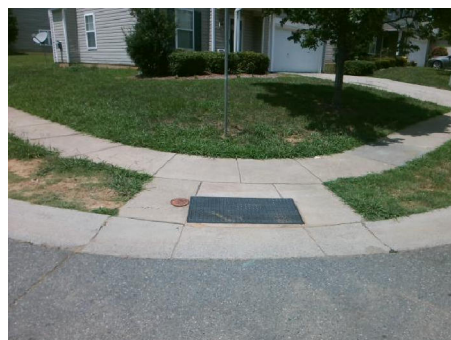
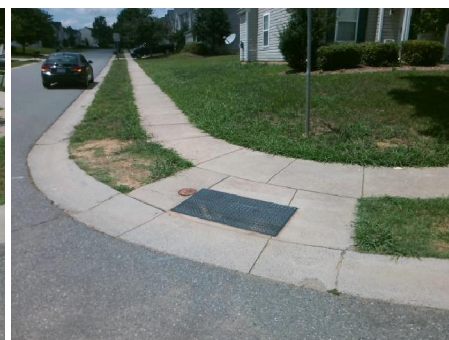
Compliance	Description	Data	Compliance	Description	Data
N/A	Ramp Length (in)	44.0	Yes	Ramp Slope (%)	6.8
No	Ramp Width (in)	37.0	Yes	Ramp XSlope (%)	1.9
N/A	Flare Type LT	N/A	N/A	Flare Type RT	N/A
N/A	Flare Slope LT (%)	N/A	N/A	Flare Slope RT (%)	N/A
N/A	Flare Traversable LT?	N/A	N/A	Flare Traversable RT?	N/A
N/A	Landing Length (in)	N/A	N/A	DWS Provided?	N/A
N/A	Landing Width (in)	N/A	N/A	DWS Contrast?	N/A
N/A	Landing Slope (%)	N/A	N/A	DWS Length (in)	N/A
N/A	Landing X Slope (%)	N/A	N/A	DWS Full Width?	N/A
N/A	Landing Curb? (Y/N)	N/A	N/A	DWS Offset (in)	N/A
N/A	Shared Landing?	N/A			
N/A	Gutter Ponding?	N/A	N/A	Gutter Slope (%)	N/A
N/A	Gutter Lip Ht (in)	N/A	N/A	Gutter X Slope (%)	N/A
N/A	Painted X Walk1?	No	N/A	Painted X Walk2?	No
	X Walk 1 Direction	To SW		X Walk 2 Direction	To SE
N/A	X Walk 1 Width (in)	N/A	N/A	X Walk 2 Width (in)	N/A
	X Walk 1 Slope (%)	0.7		X Walk 2 Slope (%)	1.4
	X Walk 1 X Slope (%)	1.1		X Walk 2 X Slope (%)	0.8

N/A	Ramp inside XWalk1?	N/A	N/A	Ramp inside XWalk2?	N/A
	Road Slope (%)	0.4	N/A	Clear Space?	N/A
	Road X Slope (%)	0.7	N/A	Clear Space to XWalk (in)	N/A
N/A	Any Obstructions?	N/A	N/A	Storm Grate/Utility Hazard?	N/A
	Obstruction Type			Storm Grate/Utility Type	
		N/A			N/A
			Yes	Surface Condition? (G/P)	Good

Possible Solutions:

Remove & Replace Curb Ramp With Two New Directional Ramps or Equivalent.

R304.5.1
