Access Compliance Report

Public Rights-of-Way

(Curb Ramps)

Intersection ID: 10018079	Main Street: CORRIENTE_CT	Cross Street: N/A	Location: SW
ADA ID: 985A88EF06DE	Ramp Type: Perp	Initial Pass/Fail: Fail	Overall Compliance: No
Severity Score: 8.75			
Codes/Mitigation Info/Possible Solution		Field Measurements/Component Compliance

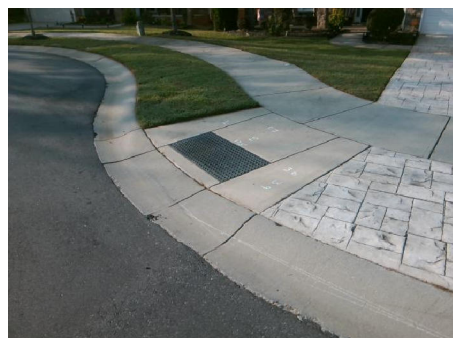
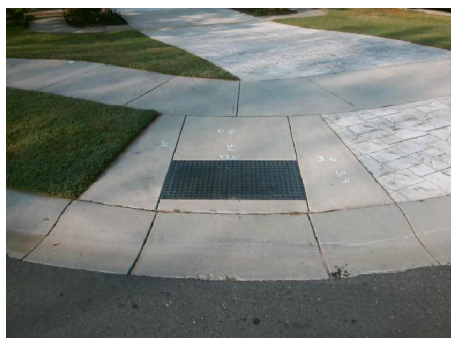
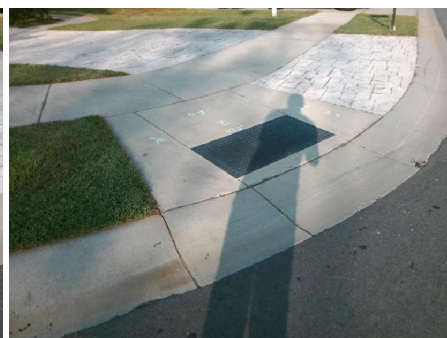
Not Found, R304.5.1

Compliance	Description	Data	Compliance	Description	Data
N/A	Ramp Length (in)	71.0	Yes	Ramp Slope (%)	5.1
No	Ramp Width (in)	47.5	Yes	Ramp XSlope (%)	0.7
N/A	Flare Type LT	N/A	N/A	Flare Type RT	N/A
N/A	Flare Slope LT (%)	N/A	N/A	Flare Slope RT (%)	N/A
N/A	Flare Traversable LT?	N/A	N/A	Flare Traversable RT?	N/A
N/A	Landing Length (in)	N/A	N/A	DWS Provided?	N/A
N/A	Landing Width (in)	N/A	N/A	DWS Contrast?	N/A
N/A	Landing Slope (%)	N/A	N/A	DWS Length (in)	N/A
N/A	Landing X Slope (%)	N/A	N/A	DWS Full Width?	N/A
N/A	Landing Curb? (Y/N)	N/A	N/A	DWS Offset (in)	N/A
N/A	Shared Landing?	N/A			
N/A	Gutter Ponding?	N/A	N/A	Gutter Slope (%)	N/A
N/A	Gutter Lip Ht (in)	N/A	N/A	Gutter X Slope (%)	N/A
N/A	Painted X Walk1?	No	N/A	Painted X Walk2?	N/A
	X Walk 1 Direction	To N		X Walk 2 Direction	N/A
N/A	X Walk 1 Width (in)	N/A	N/A	X Walk 2 Width (in)	N/A
	X Walk 1 Slope (%)	3.9		X Walk 2 Slope (%)	N/A
	X Walk 1 X Slope (%)	3.6		X Walk 2 X Slope (%)	N/A

N/A	Ramp inside XWalk1?	N/A	N/A	Ramp inside XWalk2?	N/A
	Road Slope (%)	N/A	N/A	Clear Space?	N/A
	Road X Slope (%)	N/A	N/A	Clear Space to XWalk (in)	N/A
N/A	Any Obstructions?	N/A	N/A	Storm Grate/Utility Hazard?	N/A
	Obstruction Type			Storm Grate/Utility Type	
		N/A			N/A
			Yes	Surface Condition? (G/P)	Good

Remove & Replace Entire Ramp.
