# Access Compliance Report

## Public Rights-of-Way

### (Curb Ramps)

Intersection ID: 28850	Main Street: BERWICK_RD	Cross Street: FAIRSTONE_AV	Location: NE
ADA ID: 9881625BA83D	Ramp Type: PerpDiag	Initial Pass/Fail: Fail	Overall Compliance: No
Codes/Mitigation Info/Possible Solution		Field Measurements/Component Compliance

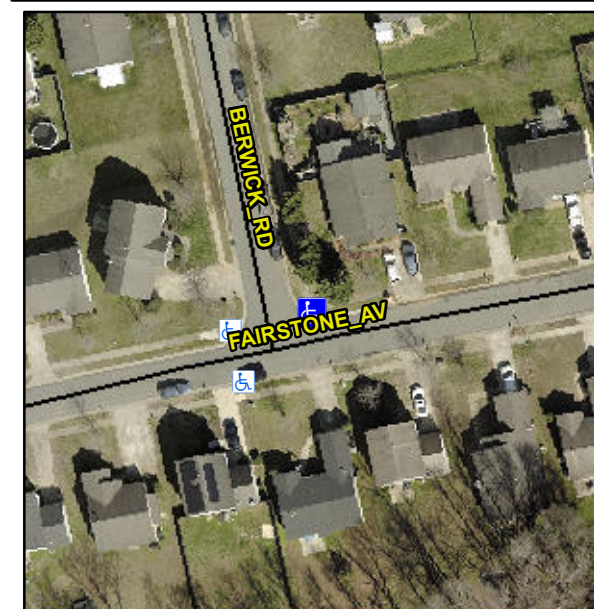
**Not Found, R304.5.3, R302.7**

Compliance	Description	Data	Compliance	Description	Data
N/A	Ramp Length (in)	48.0	Yes	Ramp Slope (%)	5.5
Yes	Ramp Width (in)	63.0	No	Ramp XSlope (%)	3.8
N/A	Flare Type LT	N/A	N/A	Flare Type RT	N/A
N/A	Flare Slope LT (%)	N/A	N/A	Flare Slope RT (%)	N/A
N/A	Flare Traversable LT?	N/A	N/A	Flare Traversable RT?	N/A
N/A	Landing Length (in)	N/A	N/A	DWS Provided?	N/A
N/A	Landing Width (in)	N/A	N/A	DWS Contrast?	N/A
N/A	Landing Slope (%)	N/A	N/A	DWS Length (in)	N/A
N/A	Landing X Slope (%)	N/A	N/A	DWS Full Width?	N/A
N/A	Landing Curb? (Y/N)	N/A	N/A	DWS Offset (in)	N/A
N/A	Shared Landing?	N/A			
N/A	Gutter Ponding?	N/A	N/A	Gutter Slope (%)	N/A
N/A	Gutter Lip Ht (in)	N/A	N/A	Gutter X Slope (%)	N/A
N/A	Painted X Walk1?	No	N/A	Painted X Walk2?	No
	X Walk 1 Direction	To W		X Walk 2 Direction	To S
N/A	X Walk 1 Width (in)	N/A	N/A	X Walk 2 Width (in)	N/A
	X Walk 1 Slope (%)	0.1		X Walk 2 Slope (%)	4.8
	X Walk 1 X Slope (%)	5.3		X Walk 2 X Slope (%)	0.3

N/A	Ramp inside XWalk1?	N/A	N/A	Ramp inside XWalk2?	N/A
	Road Slope (%)	4.5	N/A	Clear Space?	N/A
	Road X Slope (%)	4.2	N/A	Clear Space to XWalk (in)	N/A
N/A	Any Obstructions?	N/A	N/A	Storm Grate/Utility Hazard?	N/A
	Obstruction Type			Storm Grate/Utility Type	
		N/A			N/A
		No		Surface Condition? (G/P)	Poor

**Remove & Replace Curb Ramp With Two New Directional Ramps or Equivalent.**

Total Cost: \$ 3200.00
