Access Compliance Report Public Rights-of-Way (Curb Ramps)

Cross Street: SPRING GARDEN LN Location: Intersection ID: 7784 Main Street: MASSEY CT NW Initial Pass/Fail: Fail **Overall Compliance: No** 10 ADA ID: 98B8890B2F2D Ramp Type: Combination1 **Severity Score:**

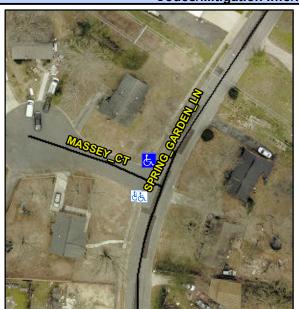
Street 1 Name StopSign **MASSEY CT** Stop Condition-Street 1 Street 2 Name N/A Stop Condition-Street 2 N/A Possible Solutions: Compliance Description Remove & Replace Entire Ramp. N/A Yes Yes No N/A No Surveyor Notes: N/A LT RP < 5% N/A N/A N/A N/A PROW/ADA: N/A Not Found, R304.5.1, R304.5.3 N/A N/A N/A N/A N/A N/A
