Access Compliance Report Public Rights-of-Way (Curb Ramps)

Main Street: WOODWARD AV **Cross Street: STATESVILLE AV** Location: Intersection ID: 9578 NE ADA ID: 98EF85AD54C0 Ramp Type: PerpDiag Initial Pass/Fail: Fail **Overall Compliance: No** 10 **Severity Score:**

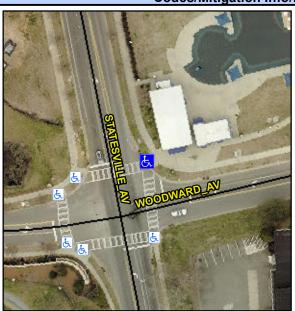
Not Found, R304.5.1, R304.5.3

•	No	Ramp Width (in)	46.5	No	Ramp XSlope (%)
	N/A	Flare Type LT	N/A	N/A	Flare Type RT
	N/A	Flare Slope LT (%)	N/A	N/A	Flare Slope RT (%)
	N/A	Flare Traversable LT?	N/A	N/A	Flare Traversable RT?
	N/A	Landing Length (in)	N/A	N/A	DWS Provided?
	N/A	Landing Width (in)	N/A	N/A	DWS Contrast?
	N/A	Landing Slope (%)	N/A	N/A	DWS Length (in)
	N/A	Landing X Slope (%)	N/A	N/A	DWS Full Width?
	N/A	Landing Curb? (Y/N)	N/A	N/A	DWS Offset (in)
	N/A	Shared Landing?	N/A		
	N/A	Gutter Ponding?	N/A	N/A	Gutter Slope (%)
	N/A	Gutter Lip Ht (in)	N/A	N/A	Gutter X Slope (%)
	N/A	Painted X Walk1?	No	N/A	Painted X Walk2?
		X Walk 1 Direction	To W		X Walk 2 Direction
	N/A	X Walk 1 Width (in)	N/A	N/A	X Walk 2 Width (in)
		X Walk 1 Slope (%)	3.0		X Walk 2 Slope (%)
		X Walk 1 X Slope (%)	1.5		X Walk 2 X Slope (%)
	N/A	Ramp inside XWalk1?	N/A	N/A	Ramp inside XWalk2?
		Road Slope (%)	1.9	N/A	Clear Space?
		Road X Slope (%)	0.6	N/A	Clear Space to XWalk (in)

STATESVILLE AV Street 1 Name Stop Condition-Street 2 Street 2 Name **WOODWARD AV** Stop Condition-Street 1 StopSign Remove & Replace Curb Ramp With Two New Directional Ramps or Equivalent.
