Access Compliance Report

Public Rights-of-Way (Curb Ramps)

Intersection ID: 10747		Main Street: DUCKWORTH_AV		Cross Street: S_BRUNS_AV		Location:		E	
ADA ID: 98FC6D1256A7		Ramp Type: Directional1		Initial Pass/Fail: Fail		Overall Compliance: No		Severity Score: 12.5	
Codes/Mitigation Info/Possible Solution				Field Measurements/Component Compliance

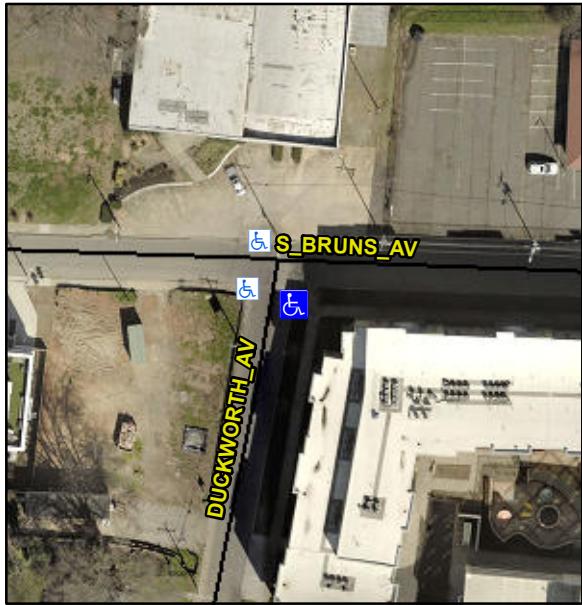
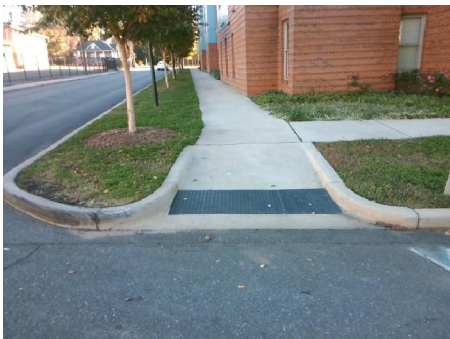
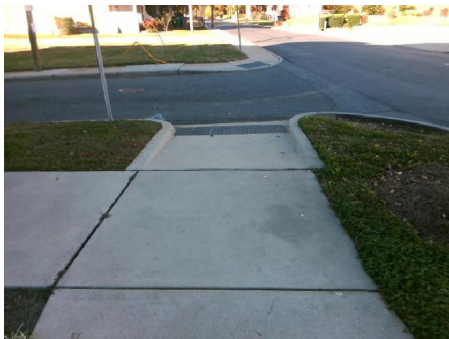
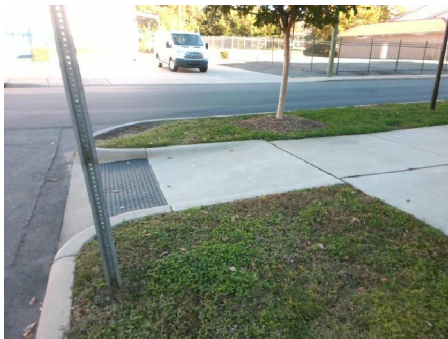
Possible Solutions:		Compliance	Description	Data	Compliance	Description	Data
		Remove & Replace Entire Ramp.		N/A	Ramp Length (in)	97.0	N/A	Grade Break?	N/A
				Yes	Ramp Width (in)	69.0	N/A	Grade Break Slope (%)	0.0
				No	Ramp Slope (%)	9.9	N/A	Grade Break XSlope (%)	0.0
				Yes	Ramp XSlope (%)	0.9			
				N/A	Flare Type LT	N/A	N/A	Flare Type RT	N/A
				N/A	Flare Slope LT (%)	N/A	N/A	Flare Slope RT (%)	0.0
				N/A	Flare Traversable LT?	N/A	N/A	Flare Traversable RT?	N/A
				N/A	Landing Length (in)	0.0	N/A	DWS Provided?	N/A
				N/A	Landing Width (in)	0.0	N/A	DWS Contrast?	N/A
Surveyor Notes: N/A				N/A	Landing Slope (%)	0.0	N/A	DWS Length (in)	N/A

N/A	Landing X Slope (%)	0.0	N/A	DWS Full Width?	N/A
				N/A	Landing Curb? (Y/N)	N/A	N/A	DWS Offset LT (in)	N/A
				N/A	Shared Landing?	N/A	N/A	DWS Offset RT (in)	N/A
				N/A	Gutter Ponding?	0.0	N/A	Gutter Slope (%)	N/A
				N/A	Gutter Lip Ht (in)	0.0	N/A	Gutter X Slope (%)	N/A
				N/A	Painted X Walk1?	No		Road Slope (%)	2.5
					X Walk 1 Direction	To W		Road X Slope (%)	3.6
					X Walk 1 Width (in)	N/A		Clear Space?	N/A
					X Walk 1 Slope (%)	2.5	N/A	Clear Space to XWalk (in)	N/A
PROW/ADA: R304.2.2					X Walk 1 X Slope (%)	3.6	N/A	Storm Grate/Utility Hazard?	N/A
				N/A	Ramp inside XWalk1?	N/A		Storm Grate/Utility Type	
				N/A	Any Obstructions?	N/A			N/A
					Obstruction Type		Yes	Surface Condition? (G/P)	Good
							N/A	Curb Slope (%)	8.8
Street 1 Name		DUCKWORTH AV							
Stop Condition-Street 1		StopSign							
Street 2 Name		N/A							
Stop Condition-Street 2		N/A							
Total Cost:		\$		1600.00
