Access Compliance Report

Public Rights-of-Way

(Curb Ramps)

Intersection ID: 6155	Main Street: OAK_DR	Cross Street: OAKBLUFF_CR	Location:	S
ADA ID: 98FD5E544B51	Ramp Type: Perp	Initial Pass/Fail: Fail	Overall Compliance: No	Severity Score: 10

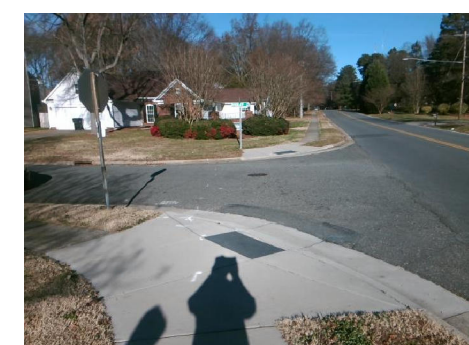
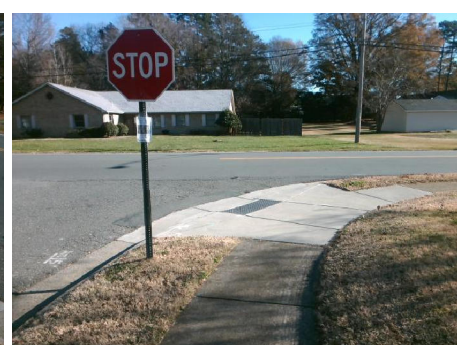
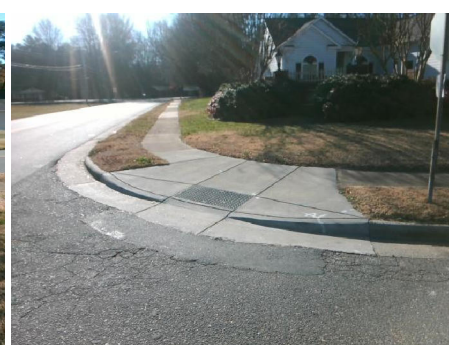
Possible Solutions:						
	Remove & Replace Entire Ramp.						
	Surveyor Notes:						
	N/A						
	PROW/ADA:						
	Not Found, R304.5.1, R304.5.3						
	Street 1 Name	OAKBLUFF CR					
	Stop Condition-Street 2	StopSign					
	Street 2 Name	N/A					
	Stop Condition-Street 1	N/A					
Total Cost:		\$	1850.00				
Compliance	Description	Data	Compliance	Description	Data		
N/A	Ramp Length (in)	99.0	Yes	Ramp Slope (%)	7.1		
No	Ramp Width (in)	46.0	No	Ramp XSlope (%)	3.5		
N/A	Flare Type LT	N/A	N/A	Flare Type RT	N/A		
N/A	Flare Slope LT (%)	N/A	N/A	Flare Slope RT (%)	N/A		
N/A	Flare Traversable LT?	N/A	N/A	Flare Traversable RT?	N/A		
N/A	Landing Length (in)	N/A	N/A	DWS Provided?	N/A		
N/A	Landing Width (in)	N/A	N/A	DWS Contrast?	N/A		
N/A	Landing Slope (%)	N/A	N/A	DWS Length (in)	N/A		
N/A	Landing X Slope (%)	N/A	N/A	DWS Full Width?	N/A

N/A	Landing Curb? (Y/N)	N/A	N/A	DWS Offset (in)	N/A		
N/A	Shared Landing?	N/A					
N/A	Gutter Ponding?	N/A	N/A	Gutter Slope (%)	N/A		
N/A	Gutter Lip Ht (in)	N/A	N/A	Gutter X Slope (%)	N/A		
N/A	Painted X Walk1?	No	N/A	Painted X Walk2?	N/A		
	X Walk 1 Direction	To NE		X Walk 2 Direction	N/A		
N/A	X Walk 1 Width (in)	N/A	N/A	X Walk 2 Width (in)	N/A		
	X Walk 1 Slope (%)	0.4		X Walk 2 Slope (%)	N/A		
	X Walk 1 X Slope (%)	3.6		X Walk 2 X Slope (%)	N/A		
N/A	Ramp inside XWalk1?	N/A	N/A	Ramp inside XWalk2?	N/A		
	Road Slope (%)	N/A	N/A	Clear Space?	N/A		
	Road X Slope (%)	N/A	N/A	Clear Space to XWalk (in)	N/A		
N/A	Any Obstructions?	N/A	N/A	Storm Grate/Utility Hazard?	N/A		
	Obstruction Type			Storm Grate/Utility Type			
		N/A			N/A		
			Yes	Surface Condition? (G/P)	Good
