# Access Compliance Report

## Public Rights-of-Way

### (Curb Ramps)

Intersection ID: 11179	Main Street: MEADOWCLIFF_DR	Cross Street: MILTON_RD	Location: S
ADA ID: 991AF5FAA0E7	Ramp Type: Perp	Initial Pass/Fail: Fail	Overall Compliance: No
			Severity Score: 18.75

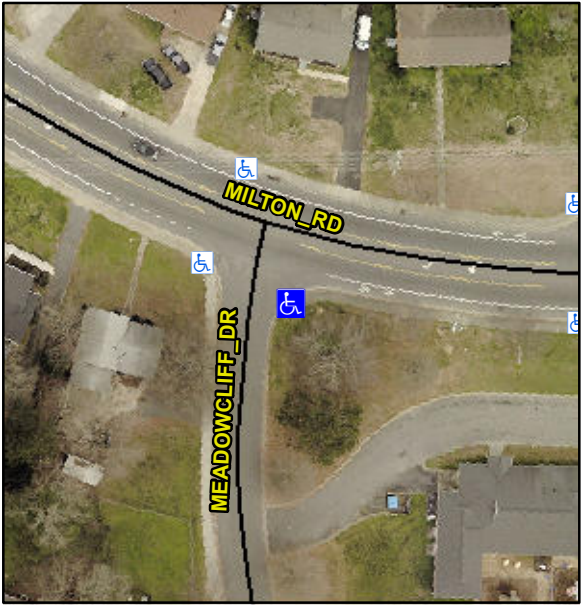
Compliance	Description	Data	Compliance	Description	Data
N/A	Ramp Length (in)	60.0	Yes	Ramp Slope (%)	7.4
No	Ramp Width (in)	35.5	No	Ramp XSlope (%)	3.6
N/A	Flare Type LT	N/A	N/A	Flare Type RT	N/A
N/A	Flare Slope LT (%)	N/A	N/A	Flare Slope RT (%)	N/A
N/A	Flare Traversable LT?	N/A	N/A	Flare Traversable RT?	N/A
N/A	Landing Length (in)	N/A	N/A	DWS Provided?	N/A
N/A	Landing Width (in)	N/A	N/A	DWS Contrast?	N/A
N/A	Landing Slope (%)	N/A	N/A	DWS Length (in)	N/A
N/A	Landing X Slope (%)	N/A	N/A	DWS Full Width?	N/A
N/A	Landing Curb? (Y/N)	N/A	N/A	DWS Offset (in)	N/A
N/A	Shared Landing?	N/A			
N/A	Gutter Ponding?	N/A	N/A	Gutter Slope (%)	N/A
N/A	Gutter Lip Ht (in)	N/A	N/A	Gutter X Slope (%)	N/A
N/A	Painted X Walk1?	No	N/A	Painted X Walk2?	N/A
	X Walk 1 Direction	To NW		X Walk 2 Direction	N/A
N/A	X Walk 1 Width (in)	N/A	N/A	X Walk 2 Width (in)	N/A
	X Walk 1 Slope (%)	1.4		X Walk 2 Slope (%)	N/A
	X Walk 1 X Slope (%)	3.6		X Walk 2 X Slope (%)	N/A

N/A	Ramp inside XWalk1?	N/A	N/A	Ramp inside XWalk2?	N/A
	Road Slope (%)	N/A	N/A	Clear Space?	N/A
	Road X Slope (%)	N/A	N/A	Clear Space to XWalk (in)	N/A
N/A	Any Obstructions?	N/A	N/A	Storm Grate/Utility Hazard?	N/A
	Obstruction Type			Storm Grate/Utility Type	
		N/A			N/A
			Yes	Surface Condition? (G/P)	Good

Possible Solutions:				
	Remove & Replace Entire Ramp.				
	Surveyor Notes:				
	N/A				
	PROW/ADA:				
	Not Found, R304.5.1, R304.5.3				
Street 1 Name	MEADOWCLIFF DR				
Stop Condition-Street 2	StopSign				
Street 2 Name	N/A				
Stop Condition-Street 1	N/A				
Total Cost:		\$	1850.00
