Access Compliance Report

Public Rights-of-Way

(Curb Ramps)

Intersection ID: 14033	Main Street: ELMIN_ST	Cross Street: MORNING_DR	Location: NW
ADA ID: 992518482B39	Ramp Type: PerpDiag	Initial Pass/Fail: Fail	Overall Compliance: No
Severity Score: 58.75			
Codes/Mitigation Info/Possible Solution		Field Measurements/Component Compliance

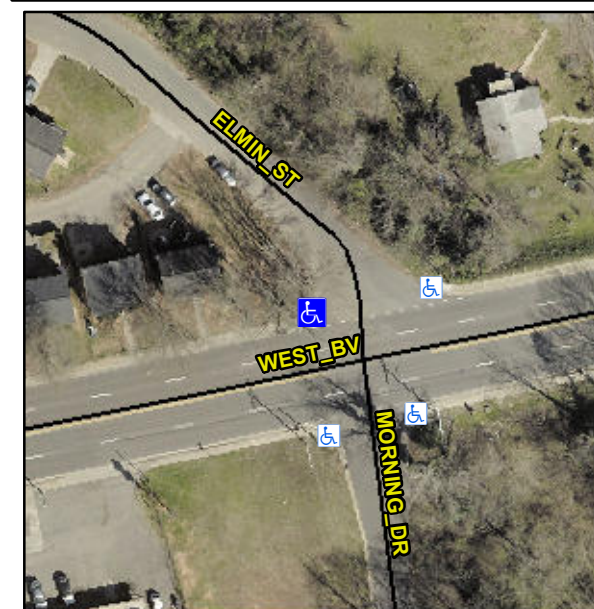
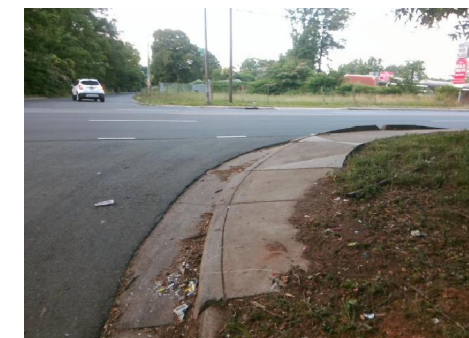
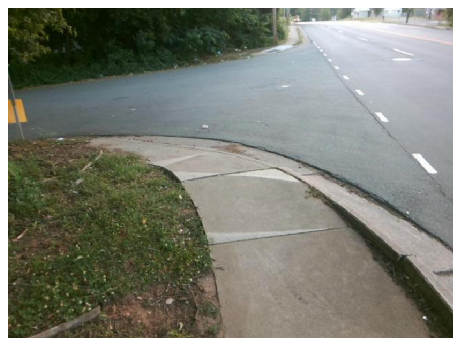
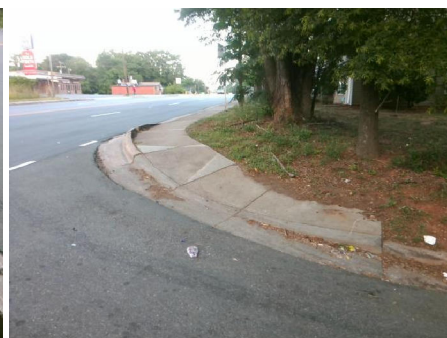
Not Found, R304.5.1, R304.2.2, R304.5.3

Compliance	Description	Data	Compliance	Description	Data
N/A	Ramp Length (in)	48.0	No	Ramp Slope (%)	14.7
No	Ramp Width (in)	42.0	No	Ramp XSlope (%)	17.0
N/A	Flare Type LT	N/A	N/A	Flare Type RT	N/A
N/A	Flare Slope LT (%)	N/A	N/A	Flare Slope RT (%)	N/A
N/A	Flare Traversable LT?	N/A	N/A	Flare Traversable RT?	N/A
N/A	Landing Length (in)	N/A	N/A	DWS Provided?	N/A
N/A	Landing Width (in)	N/A	N/A	DWS Contrast?	N/A
N/A	Landing Slope (%)	N/A	N/A	DWS Length (in)	N/A
N/A	Landing X Slope (%)	N/A	N/A	DWS Full Width?	N/A
N/A	Landing Curb? (Y/N)	N/A	N/A	DWS Offset (in)	N/A
N/A	Shared Landing?	N/A			
N/A	Gutter Ponding?	N/A	N/A	Gutter Slope (%)	N/A
N/A	Gutter Lip Ht (in)	N/A	N/A	Gutter X Slope (%)	N/A
N/A	Painted X Walk1?	No	N/A	Painted X Walk2?	No
	X Walk 1 Direction	To S		X Walk 2 Direction	To E
N/A	X Walk 1 Width (in)	N/A	N/A	X Walk 2 Width (in)	N/A
	X Walk 1 Slope (%)	7.7		X Walk 2 Slope (%)	1.4
	X Walk 1 X Slope (%)	1.8		X Walk 2 X Slope (%)	8.3

N/A	Ramp inside XWalk1?	N/A	N/A	Ramp inside XWalk2?	N/A
	Road Slope (%)	9.2	N/A	Clear Space?	N/A
	Road X Slope (%)	1.2	N/A	Clear Space to XWalk (in)	N/A
N/A	Any Obstructions?	N/A	N/A	Storm Grate/Utility Hazard?	N/A
	Obstruction Type			Storm Grate/Utility Type	
		N/A			N/A
			Yes	Surface Condition? (G/P)	Good

Remove & Replace Curb Ramp With Two New Directional Ramps or Equivalent.
