Access Compliance Report Public Rights-of-Way (Curb Ramps)

Intersection ID: 31906 Main Street: LAMOILLE_LN Cross Street: PALOMAR_MOUNTAIN_DR Location: NE
ADA ID: 994A40AC34CD Ramp Type: PerpDiag Initial Pass/Fail: Fail Overall Compliance: No Severity Score: 10

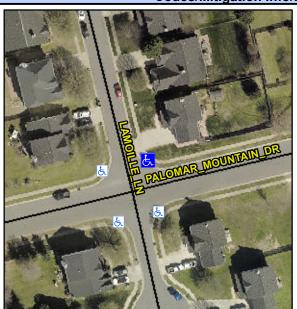
Compliance Description Data Compliance Description Data Yes N/A Ramp Length (in) 48.0 Ramp Slope (%) 5.7 No Ramp XSlope (%) No Ramp Width (in) 44.0 2.7 N/A N/A Flare Type LT N/A Flare Type RT N/A N/A Flare Slope LT (%) N/A N/A Flare Slope RT (%) N/A N/A Flare Traversable LT? N/A N/A Flare Traversable RT? N/A N/A Landing Length (in) N/A N/A DWS Provided? N/A N/A Landing Width (in) N/A N/A **DWS Contrast?** N/A N/A N/A N/A Landing Slope (%) DWS Length (in) N/A N/A Landing X Slope (%) N/A N/A DWS Full Width? N/A N/A Landing Curb? (Y/N) N/A N/A DWS Offset (in) N/A N/A N/A Shared Landing? N/A **Gutter Ponding?** N/A N/A Gutter Slope (%) N/A N/A Gutter Lip Ht (in) N/A N/A Gutter X Slope (%) N/A N/A Painted X Walk1? No N/A Painted X Walk2? No X Walk 1 Direction To W X Walk 2 Direction To S N/A N/A X Walk 2 Width (in) X Walk 1 Width (in) N/A X Walk 1 Slope (%) X Walk 2 Slope (%) 5.0 3.4 X Walk 1 X Slope (%) 1.8 X Walk 2 X Slope (%) 2.2 N/A Ramp inside XWalk1? N/A N/A Ramp inside XWalk2? N/A Road Slope (%) 0.4 N/A Clear Space? N/A N/A Road X Slope (%) 3.4 Clear Space to XWalk (in) N/A N/A N/A N/A Any Obstructions? Storm Grate/Utility Hazard? N/A **Obstruction Type** Storm Grate/Utility Type N/A N/A Yes Surface Condition? (G/P) Good

Possible Solutions:

Remove & Replace Curb Ramp With
Two New Directional Ramps or
Equivalent.

PROW/ADA:
R304.5.1, R304.5.3
