Access Compliance Report

Public Rights-of-Way

(Curb Ramps)

| Intersection ID: 44824 | Main Street: CLANTON_RD | Cross Street: GOLDEN_RIDGE_LN | Location: NE |

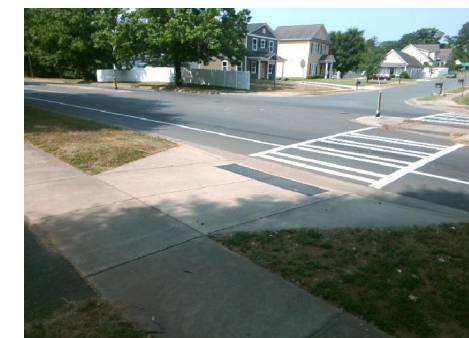
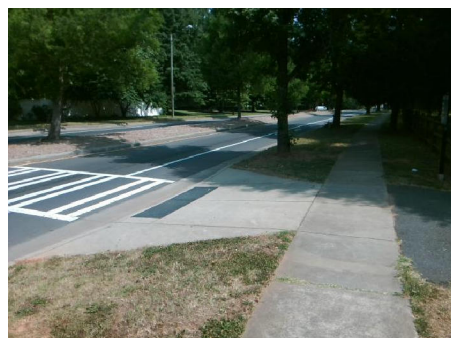
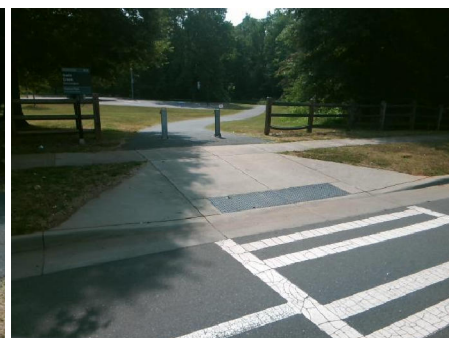
Not Found, R305.1.4

| Compliance | Description | Data | Compliance | Description | Data |
|---|---|---|---|---|---|
| Yes | Landing X Slope (%) | 0.4 | No | DWS Full Width? | No |

Remove & Replace Entire Ramp.
