| Intersection ID: 11162 | Main Street: HOLT_ST | Cross Street: THE_PLAZA | Location: | W |
| ADA ID: 995A6C42CFC1 | Ramp Type: PerpDiag | Initial Pass/Fail: Fail | Overall Compliance: No | Severity Score: 33.75 |

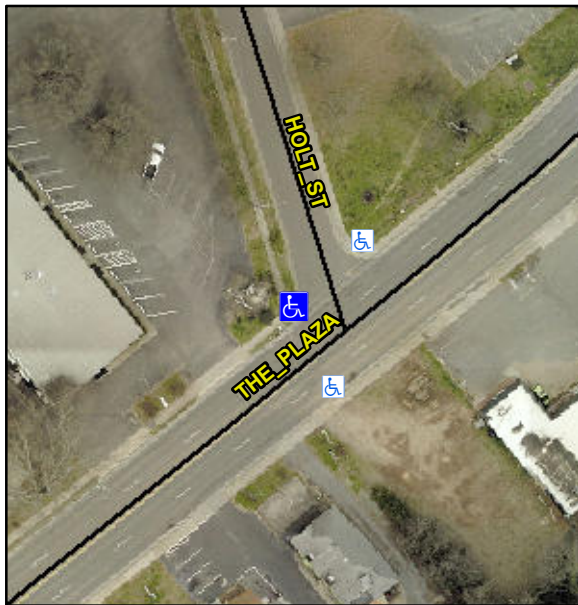
**Not Found, R304.5.1, R304.5.3**

| Compliance | Description | Data | Compliance | Description | Data |
|---|---|---|---|---|---|
| N/A | Ramp Length (in) | 77.0 | Yes | Ramp Slope (%) | 7.4 |
| No | Ramp Width (in) | 47.0 | No | Ramp XSlope (%) | 8.5 |

**Remove & Replace Curb Ramp With Two New Directional Ramps or Equivalent.**
