# Access Compliance Report

## Public Rights-of-Way

### (Curb Ramps)

Intersection ID: 13946	Main Street: DILWORTH_RD	Cross Street: E_MOREHEAD_ST	Location: SE
ADA ID: 99651D7B4977	Ramp Type: Directional1	Initial Pass/Fail: Fail	Overall Compliance: No
Severity Score: 12.5			
Codes/Mitigation Info/Possible Solution		Field Measurements/Component Compliance

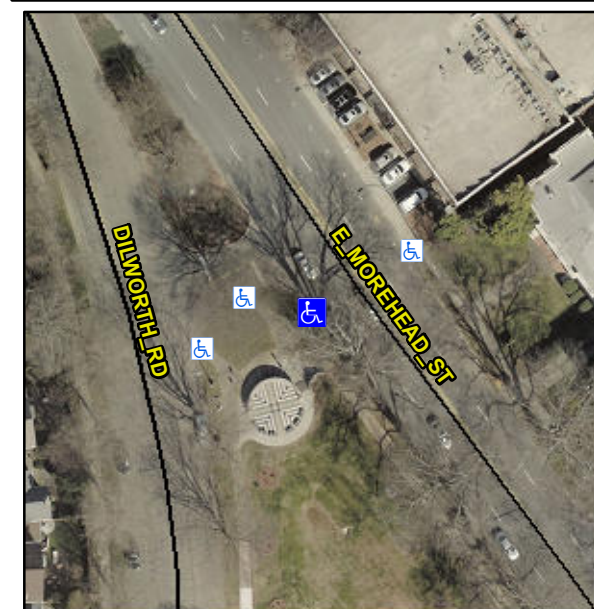
Compliance	Description	Data	Compliance	Description	Data
N/A	Ramp Length (in)	120.0	N/A	Grade Break?	N/A
Yes	Ramp Width (in)	72.0	N/A	Grade Break Slope (%)	0.0
Yes	Ramp Slope (%)	6.0	N/A	Grade Break XSlope (%)	0.0
No	Ramp XSlope (%)	5.5			
N/A	Flare Type LT	N/A	N/A	Flare Type RT	N/A
N/A	Flare Slope LT (%)	N/A	N/A	Flare Slope RT (%)	0.0
N/A	Flare Traversable LT?	N/A	N/A	Flare Traversable RT?	N/A
N/A	Landing Length (in)	0.0	N/A	DWS Provided?	N/A
N/A	Landing Width (in)	0.0	N/A	DWS Contrast?	N/A
N/A	Landing Slope (%)	0.0	N/A	DWS Length (in)	N/A
N/A	Landing X Slope (%)	0.0	N/A	DWS Full Width?	N/A
N/A	Landing Curb? (Y/N)	N/A	N/A	DWS Offset LT (in)	N/A
N/A	Shared Landing?	N/A	N/A	DWS Offset RT (in)	N/A
N/A	Gutter Ponding?	0.0	N/A	Gutter Slope (%)	N/A
N/A	Gutter Lip Ht (in)	1.0	N/A	Gutter X Slope (%)	N/A
N/A	Painted X Walk1?	No		Road Slope (%)	3.4
	X Walk 1 Direction	To NE		Road X Slope (%)	0.3
	X Walk 1 Width (in)	N/A		Clear Space?	N/A

X Walk 1 Slope (%)	3.4	N/A	Clear Space to XWalk (in)	N/A
	X Walk 1 X Slope (%)	0.3	N/A	Storm Grate/Utility Hazard?	N/A
N/A	Ramp inside XWalk1?	N/A		Storm Grate/Utility Type	
N/A	Any Obstructions?	N/A			N/A
	Obstruction Type		Yes	Surface Condition? (G/P)	Good
			N/A	Curb Slope (%)	8.4

**Remove & Replace Entire Ramp.**

**R304.5.3**

\$ 1600.00
