Access Compliance Report

Public Rights-of-Way

(Curb Ramps)

Intersection ID: 18315	Main Street: ADDISON_DR	Cross Street: LYTTLETON_DR	Location:	N
ADA ID: 996D14E899BE	Ramp Type: PerpDiag	Initial Pass/Fail: Fail	Overall Compliance: No	Severity Score: 22.5

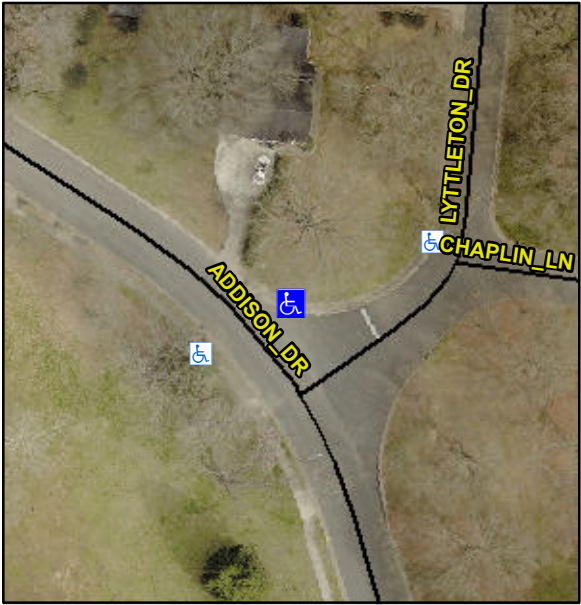
<p>Possible Solutions:</p> <p>Remove & Replace Curb Ramp With Two New Directional Ramps or Equivalent.</p> <p>Surveyor Notes:</p> <p>N/A</p> <p>PROW/ADA:</p> <p>Not Found, R304.5.1, R304.2.2, R304.5.3</p>	Total Cost:		\$	3200.00		
	Street 1 Name	ADDISON DR		Street 2 Name	LYTTLETON DR	
	Stop Condition-Street 2	None		Stop Condition-Street 1	StopSign	
	Compliance	Description	Data	Compliance	Description	Data
	N/A	Ramp Length (in)	48.0	No	Ramp Slope (%)	10.2
	No	Ramp Width (in)	45.8	No	Ramp XSlope (%)	3.0
	N/A	Flare Type LT	N/A	N/A	Flare Type RT	N/A
	N/A	Flare Slope LT (%)	N/A	N/A	Flare Slope RT (%)	N/A
	N/A	Flare Traversable LT?	N/A	N/A	Flare Traversable RT?	N/A
	N/A	Landing Length (in)	N/A	N/A	DWS Provided?	N/A
	N/A	Landing Width (in)	N/A	N/A	DWS Contrast?	N/A
	N/A	Landing Slope (%)	N/A	N/A	DWS Length (in)	N/A
	N/A	Landing X Slope (%)	N/A	N/A	DWS Full Width?	N/A

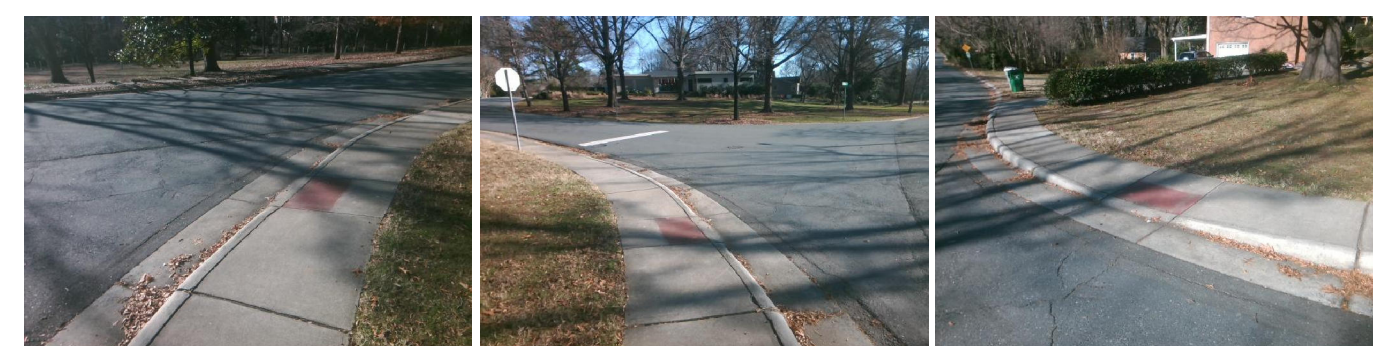
N/A	Landing Curb? (Y/N)	N/A	N/A	DWS Offset (in)	N/A
	N/A	Shared Landing?	N/A	N/A	Gutter Slope (%)	N/A
	N/A	Gutter Ponding?	N/A	N/A	Gutter X Slope (%)	N/A
	N/A	Gutter Lip Ht (in)	N/A	N/A	Painted X Walk2?	No
	N/A	Painted X Walk1?	No	N/A	X Walk 2 Direction	To SE
	N/A	X Walk 1 Direction	To SW	N/A	X Walk 2 Width (in)	N/A
	N/A	X Walk 1 Width (in)	N/A	N/A	X Walk 2 Slope (%)	2.2
	N/A	X Walk 1 Slope (%)	0.9	N/A	X Walk 2 X Slope (%)	1.4
	N/A	X Walk 1 X Slope (%)	1.4	N/A	Ramp inside XWalk2?	N/A
	N/A	Ramp inside XWalk1?	N/A	N/A	Clear Space?	N/A
	N/A	Road Slope (%)	1.0	N/A	Clear Space to XWalk (in)	N/A
	N/A	Road X Slope (%)	1.1	N/A	Storm Grate/Utility Hazard?	N/A
	N/A	Any Obstructions?	N/A	N/A	Storm Grate/Utility Type	N/A
	N/A	Obstruction Type	N/A	N/A	Surface Condition? (G/P)	Good
