# Access Compliance Report

## Public Rights-of-Way

### (Curb Ramps)

Intersection ID: 53635	Main Street: NEWBURY GROVE ST	Cross Street: TREMONT RIDGE CT	Location: SW
ADA ID: 996D21D7F673	Ramp Type: Perp	Initial Pass/Fail: Fail	Overall Compliance: No
Codes/Mitigation Info/Possible Solution		Field Measurements/Component Compliance	
Severity Score: 13.75

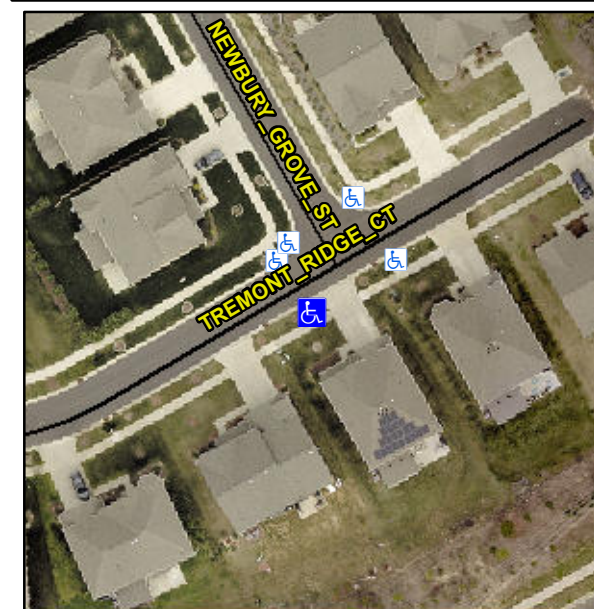
**Not Found, R304.2.2, R304.5.3**

Compliance	Description	Data	Compliance	Description	Data
N/A	Ramp Length (in)	95.0	No	Ramp Slope (%)	9.2
Yes	Ramp Width (in)	59.0	No	Ramp XSlope (%)	3.0
N/A	Flare Type LT	N/A	N/A	Flare Type RT	N/A
N/A	Flare Slope LT (%)	N/A	N/A	Flare Slope RT (%)	N/A
N/A	Flare Traversable LT?	N/A	N/A	Flare Traversable RT?	N/A
N/A	Landing Length (in)	N/A	N/A	DWS Provided?	N/A
N/A	Landing Width (in)	N/A	N/A	DWS Contrast?	N/A
N/A	Landing Slope (%)	N/A	N/A	DWS Length (in)	N/A
N/A	Landing X Slope (%)	N/A	N/A	DWS Full Width?	N/A
N/A	Landing Curb? (Y/N)	N/A	N/A	DWS Offset (in)	N/A
N/A	Shared Landing?	N/A			
N/A	Gutter Ponding?	N/A	N/A	Gutter Slope (%)	N/A
N/A	Gutter Lip Ht (in)	N/A	N/A	Gutter X Slope (%)	N/A
N/A	Painted X Walk1?	No	N/A	Painted X Walk2?	N/A
	X Walk 1 Direction	To NW		X Walk 2 Direction	N/A
N/A	X Walk 1 Width (in)	N/A	N/A	X Walk 2 Width (in)	N/A
	X Walk 1 Slope (%)	0.2		X Walk 2 Slope (%)	N/A
	X Walk 1 X Slope (%)	2.4		X Walk 2 X Slope (%)	N/A

N/A	Ramp inside XWalk1?	N/A	N/A	Ramp inside XWalk2?	N/A
	Road Slope (%)	N/A	N/A	Clear Space?	N/A
	Road X Slope (%)	N/A	N/A	Clear Space to XWalk (in)	N/A
N/A	Any Obstructions?	N/A	N/A	Storm Grate/Utility Hazard?	N/A
	Obstruction Type			Storm Grate/Utility Type	
		N/A			N/A
			Yes	Surface Condition? (G/P)	Good

**Remove & Replace Entire Ramp.**

Total Cost: \$ 1850.00
