Access Compliance Report

Public Rights-of-Way

(Curb Ramps)

Intersection ID: 5097	Main Street: CARDINGTON_CT	Cross Street: PENNYCROSS_LN	Location: SE
ADA ID: 997E0D335EAB	Ramp Type: Perp	Initial Pass/Fail: Fail	Overall Compliance: No
Severity Score: 13.75			
Codes/Mitigation Info/Possible Solution		Field Measurements/Component Compliance

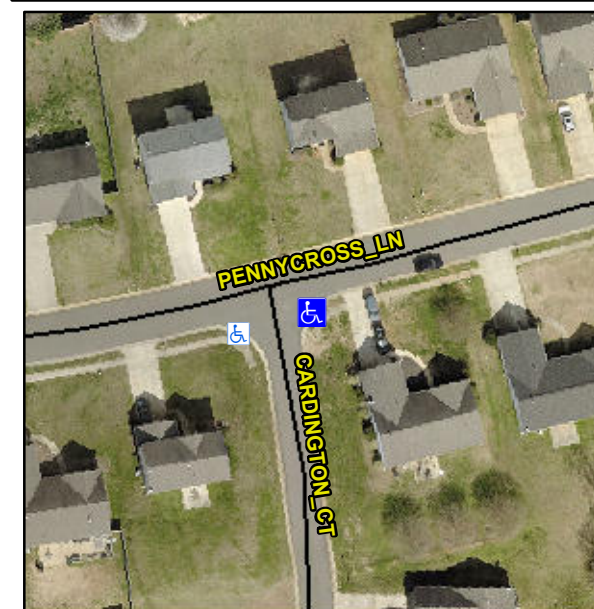
Not Found, R304.2.2, R304.5.3

Compliance	Description	Data	Compliance	Description	Data
N/A	Ramp Length (in)	81.0	No	Ramp Slope (%)	9.2
Yes	Ramp Width (in)	48.0	No	Ramp XSlope (%)	3.1
N/A	Flare Type LT	N/A	N/A	Flare Type RT	N/A
N/A	Flare Slope LT (%)	N/A	N/A	Flare Slope RT (%)	N/A
N/A	Flare Traversable LT?	N/A	N/A	Flare Traversable RT?	N/A
N/A	Landing Length (in)	N/A	N/A	DWS Provided?	N/A
N/A	Landing Width (in)	N/A	N/A	DWS Contrast?	N/A
N/A	Landing Slope (%)	N/A	N/A	DWS Length (in)	N/A
N/A	Landing X Slope (%)	N/A	N/A	DWS Full Width?	N/A
N/A	Landing Curb? (Y/N)	N/A	N/A	DWS Offset (in)	N/A
N/A	Shared Landing?	N/A			
N/A	Gutter Ponding?	N/A	N/A	Gutter Slope (%)	N/A
N/A	Gutter Lip Ht (in)	N/A	N/A	Gutter X Slope (%)	N/A
N/A	Painted X Walk1?	No	N/A	Painted X Walk2?	N/A
	X Walk 1 Direction	To W		X Walk 2 Direction	N/A
N/A	X Walk 1 Width (in)	N/A	N/A	X Walk 2 Width (in)	N/A
	X Walk 1 Slope (%)	1.7		X Walk 2 Slope (%)	N/A
	X Walk 1 X Slope (%)	4.5		X Walk 2 X Slope (%)	N/A

N/A	Ramp inside XWalk1?	N/A	N/A	Ramp inside XWalk2?	N/A
	Road Slope (%)	N/A	N/A	Clear Space?	N/A
	Road X Slope (%)	N/A	N/A	Clear Space to XWalk (in)	N/A
N/A	Any Obstructions?	N/A	N/A	Storm Grate/Utility Hazard?	N/A
	Obstruction Type			Storm Grate/Utility Type	
		N/A			N/A
		Yes		Surface Condition? (G/P)	Good

Remove & Replace Entire Ramp.
