Access Compliance Report Public Rights-of-Way (Curb Ramps)

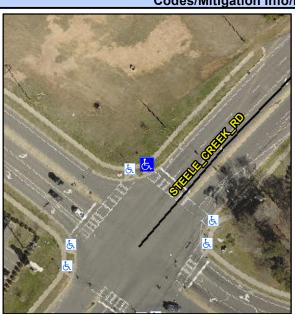
Total Cost:	\$ 1850.00

Field Measurements/Component Compliance							
Compl	iance Description	Data	Comp	iance Description	Data		
N/A	Ramp Length (in)	96.0	No	Ramp Slope (%)	9.5		
Yes	Ramp Width (in)	48.0	No	Ramp XSlope (%)	2.9		
N/A	Flare Type LT	N/A	N/A	Flare Type RT	N/A		
N/A	Flare Slope LT (%)	N/A	N/A	Flare Slope RT (%)	N/A		
N/A	Flare Traversable LT?	N/A	N/A	Flare Traversable RT?	N/A		
N/A	Landing Length (in)	N/A	N/A	DWS Provided?	N/A		
N/A	Landing Width (in)	N/A	N/A	DWS Contrast?	N/A		
N/A	Landing Slope (%)	N/A	N/A	DWS Length (in)	N/A		
N/A	Landing X Slope (%)	N/A	N/A	DWS Full Width?	N/A		
N/A	Landing Curb? (Y/N)	N/A	N/A	DWS Offset (in)	N/A		
N/A	Shared Landing?	N/A					
N/A	Gutter Ponding?	N/A	N/A	Gutter Slope (%)	N/A		
N/A	Gutter Lip Ht (in)	N/A	N/A	Gutter X Slope (%)	N/A		
N/A	Painted X Walk1?	Yes	N/A	Painted X Walk2?	N/A		
	X Walk 1 Direction	To SE		X Walk 2 Direction	N/A		
N/A	X Walk 1 Width (in)	112.0	N/A	X Walk 2 Width (in)	N/A

Street 1 Name STEELE CREEK RD Stop Condition-Street 2 Signal Street 2 Name N/A Stop Condition-Street 1 N/A

POSSIBLE SOLUTION	
Possible Solutions:	
Remove & Replace Entire Ramp.	ı
	•
	I
Surveyor Notes:	
·	
N/A	
	ı
	I
	ı
PROW/ADA:	ı
Not Found, R304.2.2, R304.5.3	ı
	-
	ı
