Access Compliance Report

Public Rights-of-Way

(Curb Ramps)

Intersection ID: 21577	Main Street: SARDIS_CROSSING_DR	Cross Street: GALLERIA_BV	Location: NE
ADA ID: 99AFC1013AB8	Ramp Type: PerpDiag	Initial Pass/Fail: Fail	Overall Compliance: No
Severity Score: 22.5			
Codes/Mitigation Info/Possible Solution		Field Measurements/Component Compliance

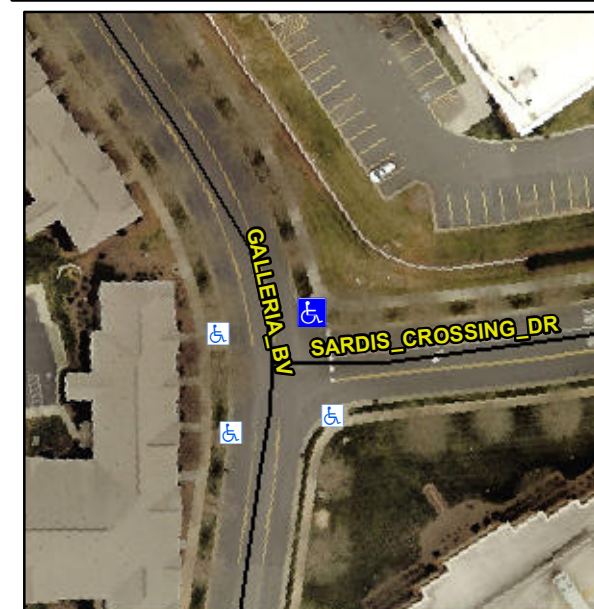
Compliance	Description	Data	Compliance	Description	Data
N/A	Ramp Length (in)	96.0	No	Ramp Slope (%)	8.9
No	Ramp Width (in)	38.0	No	Ramp XSlope (%)	2.5
N/A	Flare Type LT	N/A	N/A	Flare Type RT	N/A
N/A	Flare Slope LT (%)	N/A	N/A	Flare Slope RT (%)	N/A
N/A	Flare Traversable LT?	N/A	N/A	Flare Traversable RT?	N/A
N/A	Landing Length (in)	N/A	N/A	DWS Provided?	N/A
N/A	Landing Width (in)	N/A	N/A	DWS Contrast?	N/A
N/A	Landing Slope (%)	N/A	N/A	DWS Length (in)	N/A
N/A	Landing X Slope (%)	N/A	N/A	DWS Full Width?	N/A
N/A	Landing Curb? (Y/N)	N/A	N/A	DWS Offset (in)	N/A
N/A	Shared Landing?	N/A			
N/A	Gutter Ponding?	N/A	N/A	Gutter Slope (%)	N/A
N/A	Gutter Lip Ht (in)	N/A	N/A	Gutter X Slope (%)	N/A
N/A	Painted X Walk1?	No	N/A	Painted X Walk2?	No
	X Walk 1 Direction	To W		X Walk 2 Direction	To S
N/A	X Walk 1 Width (in)	N/A	N/A	X Walk 2 Width (in)	N/A
	X Walk 1 Slope (%)	3.4		X Walk 2 Slope (%)	1.6
	X Walk 1 X Slope (%)	2.9		X Walk 2 X Slope (%)	2.1

N/A	Ramp inside XWalk1?	N/A	N/A	Ramp inside XWalk2?	N/A
	Road Slope (%)	0.8	N/A	Clear Space?	N/A
	Road X Slope (%)	5.0	N/A	Clear Space to XWalk (in)	N/A
N/A	Any Obstructions?	N/A	N/A	Storm Grate/Utility Hazard?	N/A
	Obstruction Type			Storm Grate/Utility Type	
		N/A			N/A
			Yes	Surface Condition? (G/P)	Good

Possible Solutions:

Remove & Replace Curb Ramp With Two New Directional Ramps or Equivalent.
