# Access Compliance Report

## Public Rights-of-Way

### (Curb Ramps)

Intersection ID: 15287	Main Street: ALBEMARLE_RD	Cross Street: N_SHARON_AMITY_RD	Location: SW
ADA ID: 99B73E38F595	Ramp Type: Para	Initial Pass/Fail: Fail	Overall Compliance: No
			Severity Score: 13.75

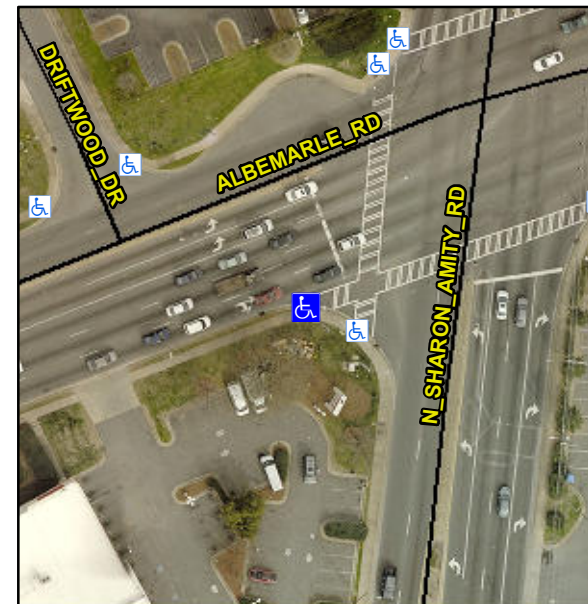
**RT RP < 5%**

**R304.3.2, R304.5.3**

Compliance	Description	Data	Compliance	Description	Data
N/A	Ramp Length LT (in)	64.5	N/A	Ramp Length RT (in)	59.5
Yes	Ramp Width LT (in)	65.5	Yes	Ramp Width RT (in)	69.0
No	Ramp Slope LT (%)	8.7	Yes	Ramp Slope RT (%)	3.8
No	Ramp XSlope LT (%)	2.2	Yes	Ramp XSlope RT (%)	1.7
N/A	Landing Length (in)	N/A	N/A	DWS Provided?	N/A
N/A	Landing Width (in)	N/A	N/A	DWS Contrast?	N/A
N/A	Landing Slope (%)	N/A	N/A	DWS Length (in)	N/A
N/A	Landing X Slope (%)	N/A	N/A	DWS Full Width?	N/A
N/A	Landing Curb? (Y/N)	N/A	N/A	DWS Offset (in)	N/A
N/A	Shared Landing?	N/A			
N/A	Gutter Ponding?	N/A	N/A	Gutter Slope (%)	N/A
N/A	Gutter Lip Ht (in)	N/A	N/A	Gutter X Slope (%)	N/A
N/A	Painted X Walk1?	Yes	N/A	Painted X Walk2?	N/A
	X Walk 1 Direction	To E		X Walk 2 Direction	N/A
N/A	X Walk 1 Width (in)	110.0	N/A	X Walk 2 Width (in)	N/A
	X Walk 1 Slope (%)	0.3		X Walk 2 Slope (%)	N/A
	X Walk 1 X Slope (%)	3.6		X Walk 2 X Slope (%)	N/A
N/A	Ramp inside XWalk1?	Yes	N/A	Ramp inside XWalk2?	N/A

Road Slope (%)	N/A	N/A	Clear Space?	N/A
	Road X Slope (%)	N/A	N/A	Clear Space to XWalk (in)	N/A
N/A	Any Obstructions?	N/A	N/A	Storm Grate/Utility Hazard?	N/A
	Obstruction Type			Storm Grate/Utility Type	
		N/A			N/A
			Yes	Surface Condition? (G/P)	Good
			N/A	Curb Slope (%)	22.2

**Remove & Replace Entire Ramp.**

Total Cost: \$ 1600.00
