Access Compliance Report

Public Rights-of-Way

(Curb Ramps)

| Intersection ID: 45827 | Main Street: CHRISTENBURY_RD | Cross Street: CHRISTENBURY_HILLS_LN | Location: | N |

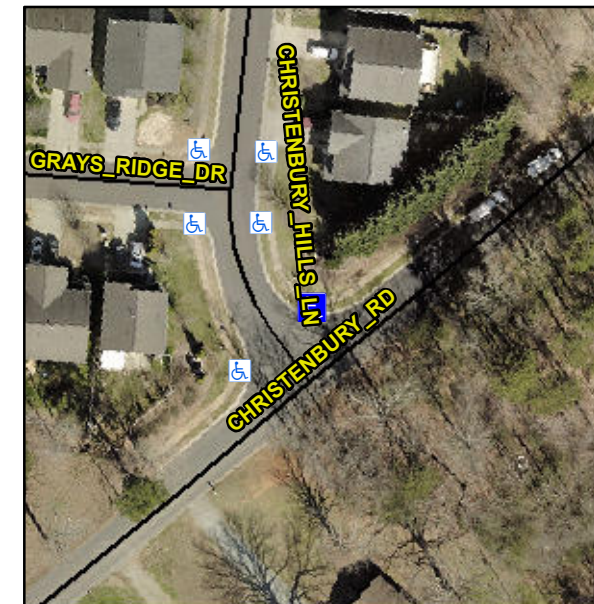
| ADA ID: 99B859046A5B | Ramp Type: Perp | Initial Pass/Fail: Fail | Overall Compliance: No | Severity Score: 33.75 |

Not Found, R304.5.1, R304.2.2, R304.5.3

| Compliance | Description | Data | Compliance | Description | Data |
|---|---|---|---|---|---|
| N/A | Ramp Length (in) | 49.5 | No | Ramp Slope (%) | 10.5 |
| No | Ramp Width (in) | 36.5 | No | Ramp XSlope (%) | 5.5 |

Possible Solutions:

Remove & Replace Entire Ramp.
