Access Compliance Report

Public Rights-of-Way

(Curb Ramps)

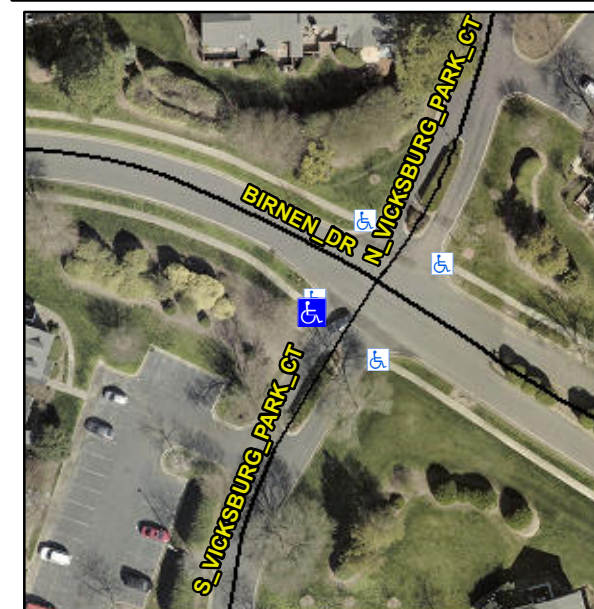
Intersection ID: 24384	Main Street: BIRNEN_DR	Cross Street: N_VICKSBURG_PARK_CT	Location: W
ADA ID: 99BB8A23BE76	Ramp Type: Directional1	Initial Pass/Fail: Fail	Overall Compliance: No
Severity Score: 12.5			
Codes/Mitigation Info/Possible Solution		Field Measurements/Component Compliance

Compliance	Description	Data	Compliance	Description	Data
N/A	Ramp Length (in)	49.0	N/A	Grade Break?	N/A
Yes	Ramp Width (in)	48.1	N/A	Grade Break Slope (%)	0.0
Yes	Ramp Slope (%)	5.1	N/A	Grade Break XSlope (%)	0.0
No	Ramp XSlope (%)	6.7			
N/A	Flare Type LT	N/A	N/A	Flare Type RT	N/A
N/A	Flare Slope LT (%)	N/A	N/A	Flare Slope RT (%)	0.0
N/A	Flare Traversable LT?	N/A	N/A	Flare Traversable RT?	N/A
N/A	Landing Length (in)	0.0	N/A	DWS Provided?	N/A
N/A	Landing Width (in)	0.0	N/A	DWS Contrast?	N/A
N/A	Landing Slope (%)	0.0	N/A	DWS Length (in)	N/A
N/A	Landing X Slope (%)	0.0	N/A	DWS Full Width?	N/A
N/A	Landing Curb? (Y/N)	N/A	N/A	DWS Offset LT (in)	N/A
N/A	Shared Landing?	N/A	N/A	DWS Offset RT (in)	N/A
N/A	Gutter Ponding?	0.0	N/A	Gutter Slope (%)	N/A
N/A	Gutter Lip Ht (in)	0.0	N/A	Gutter X Slope (%)	N/A
N/A	Painted X Walk1?	No		Road Slope (%)	0.6
	X Walk 1 Direction	To E		Road X Slope (%)	2.9
	X Walk 1 Width (in)	N/A		Clear Space?	N/A

X Walk 1 Slope (%)	0.6	N/A	Clear Space to XWalk (in)	N/A
	X Walk 1 X Slope (%)	2.9	N/A	Storm Grate/Utility Hazard?	N/A
N/A	Ramp inside XWalk1?	N/A		Storm Grate/Utility Type	
N/A	Any Obstructions?	N/A			N/A
	Obstruction Type		Yes	Surface Condition? (G/P)	Good
			N/A	Curb Slope (%)	14.5

Possible Solutions:

Remove & Replace Entire Ramp.

R304.5.3

\$ 1600.00
