Access Compliance Report Public Rights-of-Way (Curb Ramps)

Intersection ID: 45511 Main St	n ID: 45511 Main Street: MEADOW_BOTTOM_RD			Cross Street: GINHOUSE_LN			
ADA ID: 99C03BF8BD1E Ramp T	Initial Pass/Fail: Fail Overall Compliance: No			Severity Score:	13.75		
Codes/Mitigation Info/Possible Solution		Field Measurements/Component Compliance					
	Possible Solutions:				Compliance Description Data		Data

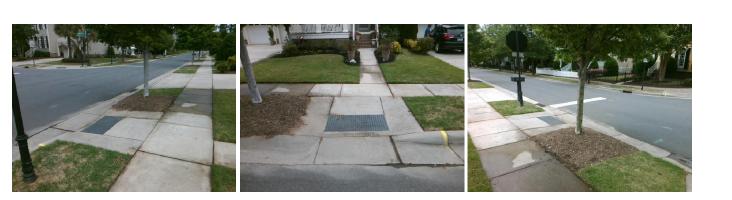
1. J. D. M. Mark	Remove & Replace Entire Ramp.	N/A	Ramp Length (in)	69.0	No	Ramp Slope (%)	8.8
	······································	Yes	Ramp Width (in)	48.0	No	Ramp XSlope (%)	2.3
		N/A	Flare Type LT	N/A	N/A	Flare Type RT	N/A
	1954	N/A	Flare Slope LT (%)	N/A	N/A	Flare Slope RT (%)	N/A
		N/A	Flare Traversable LT?	N/A	N/A	Flare Traversable RT?	N/A
	1	N/A	Landing Length (in)	N/A	N/A	DWS Provided?	N/A
	Surveyor Notes:	N/A	Landing Width (in)	N/A	N/A	DWS Contrast?	N/A
	N/A	N/A	Landing Slope (%)	N/A	N/A	DWS Length (in)	N/A
THE PARTY AND		N/A	Landing X Slope (%)	N/A	N/A	DWS Full Width?	N/A
ettere by	×	N/A	Landing Curb? (Y/N)	N/A	N/A	DWS Offset (in)	N/A
	6	N/A	Shared Landing?	N/A			
	PROW/ADA:	N/A	Gutter Ponding?	N/A	N/A	Gutter Slope (%)	N/A
	Not Found, R304.2.2, R304.5.3	N/A	Gutter Lip Ht (in)	N/A	N/A	Gutter X Slope (%)	N/A
		N/A	Painted X Walk1?	No	N/A	Painted X Walk2?	N/A
			X Walk 1 Direction	To SW		X Walk 2 Direction	N/A
