Intersection ID: 47568	Main Street: HERMSLEY_RD	Cross Street: WINDYGAP_RD	Location:	S
ADA ID: 99DBEEC7D003	Ramp Type: PerpDiag	Initial Pass/Fail: Fail	Overall Compliance: No	Severity Score: 26.25

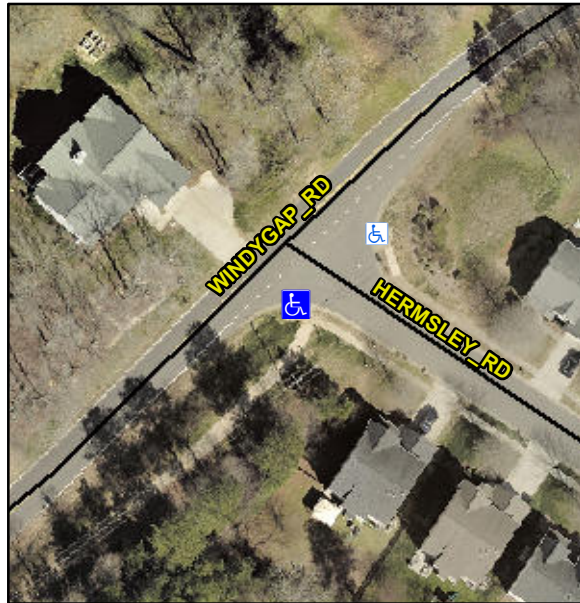
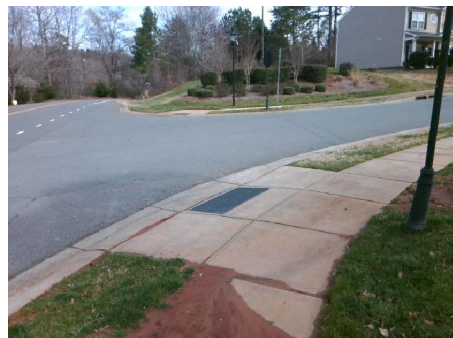
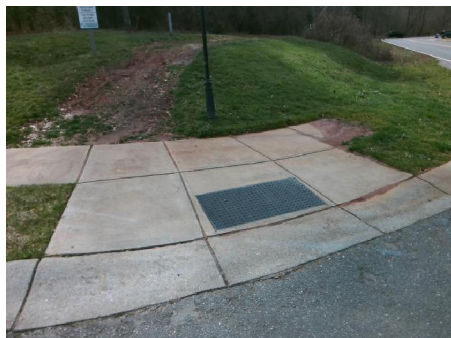
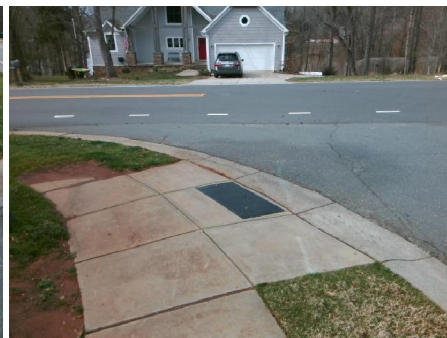
R304.2.2, R304.5.3

Possible Solutions:			Compliance	Description	Data	Compliance	Description	Data
Remove & Replace Curb Ramp With Two New Directional Ramps or Equivalent.	N/A	Ramp Length (in)	48.0	No	Ramp Slope (%)	12.0		
	Yes	Ramp Width (in)	48.0	No	Ramp XSlope (%)	3.3		
	N/A	Flare Type LT	N/A	N/A	Flare Type RT	N/A		
	N/A	Flare Slope LT (%)	N/A	N/A	Flare Slope RT (%)	N/A		
	N/A	Flare Traversable LT?	N/A	N/A	Flare Traversable RT?	N/A		
	N/A	Landing Length (in)	N/A	N/A	DWS Provided?	N/A		
	N/A	Landing Width (in)	N/A	N/A	DWS Contrast?	N/A		
	N/A	Landing Slope (%)	N/A	N/A	DWS Length (in)	N/A		
	N/A	Landing X Slope (%)	N/A	N/A	DWS Full Width?	N/A		
	N/A	Landing Curb? (Y/N)	N/A	N/A	DWS Offset (in)	N/A		
	N/A	Shared Landing?	N/A					
	N/A	Gutter Ponding?	N/A	N/A	Gutter Slope (%)	N/A		
Surveyor Notes: N/A	N/A	Gutter Lip Ht (in)	N/A	N/A	Gutter X Slope (%)	N/A		
	N/A	Painted X Walk1?	No	N/A	Painted X Walk2?	No		
		X Walk 1 Direction	To NE		X Walk 2 Direction	To NW

N/A	X Walk 1 Width (in)	N/A	N/A	X Walk 2 Width (in)	N/A		
		X Walk 1 Slope (%)	2.5		X Walk 2 Slope (%)	4.6		
		X Walk 1 X Slope (%)	4.0		X Walk 2 X Slope (%)	0.5		
	N/A	Ramp inside XWalk1?	N/A	N/A	Ramp inside XWalk2?	N/A		
		Road Slope (%)	2.7	N/A	Clear Space?	N/A		
		Road X Slope (%)	4.3	N/A	Clear Space to XWalk (in)	N/A		
	N/A	Any Obstructions?	N/A	N/A	Storm Grate/Utility Hazard?	N/A		
		Obstruction Type			Storm Grate/Utility Type			
			N/A			N/A		
Total Cost: \$ 3200.00			Yes	Surface Condition? (G/P)	Good

Remove & Replace Curb Ramp With Two New Directional Ramps or Equivalent.
