# Access Compliance Report

## Public Rights-of-Way

### (Curb Ramps)

| Intersection ID: 42778 | Main Street: CLEOPATRA_DR | Cross Street: SILVERSWORD_DR | Location: | N |

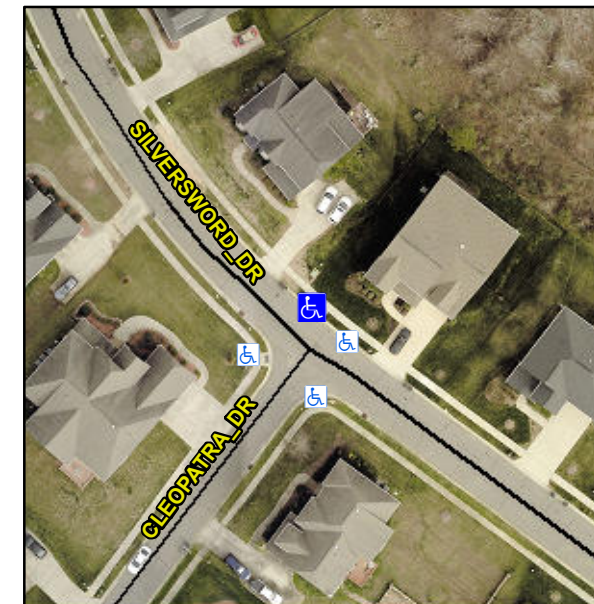
| ADA ID: 99E197AED3D4 | Ramp Type: BlendTrans1 | Initial Pass/Fail: Fail | Overall Compliance: No | Severity Score: 8.75 |

**Not Found, R304.5.1**

| Compliance | Description | Data | Compliance | Description | Data |
|---|---|---|---|---|---|
| No | Ramp Width (in) | 46.5 | Yes | BlendTrans XSlope (%) | 1.6 |
| | | | No | Curb Slope (%) | 26.2 |

**Remove & Replace Curb Ramp With Two New Directional Ramps or Equivalent.**
