Access Compliance Report

Public Rights-of-Way

(Curb Ramps)

Intersection ID: 9045	Main Street: JENNINGS_ST	Cross Street: VINTON_ST	Location: NW
ADA ID: 99E493EF9BFD	Ramp Type: Perp	Initial Pass/Fail: Fail	Overall Compliance: No
		Severity Score: 22.5

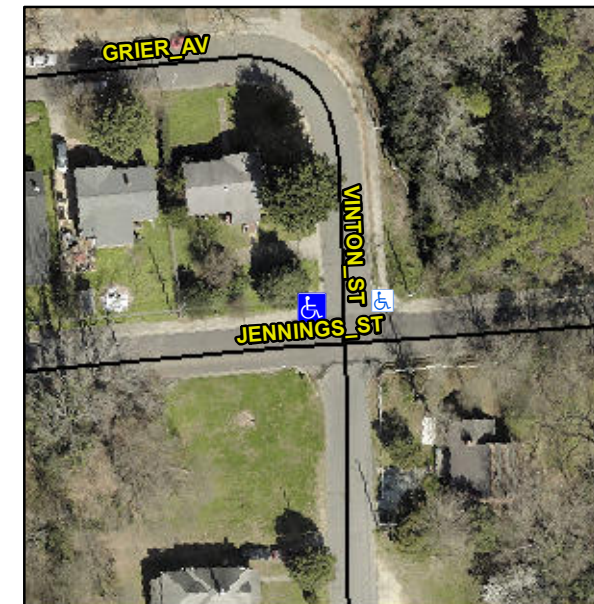
Not Found, R304.5.1, R304.2.2, R304.5.3

Compliance	Description	Data	Compliance	Description	Data
N/A	Ramp Length (in)	48.5	No	Ramp Slope (%)	9.7
No	Ramp Width (in)	45.0	No	Ramp XSlope (%)	2.5
N/A	Flare Type LT	N/A	N/A	Flare Type RT	N/A
N/A	Flare Slope LT (%)	N/A	N/A	Flare Slope RT (%)	N/A
N/A	Flare Traversable LT?	N/A	N/A	Flare Traversable RT?	N/A
N/A	Landing Length (in)	N/A	N/A	DWS Provided?	N/A
N/A	Landing Width (in)	N/A	N/A	DWS Contrast?	N/A
N/A	Landing Slope (%)	N/A	N/A	DWS Length (in)	N/A
N/A	Landing X Slope (%)	N/A	N/A	DWS Full Width?	N/A
N/A	Landing Curb? (Y/N)	N/A	N/A	DWS Offset (in)	N/A
N/A	Shared Landing?	N/A			
N/A	Gutter Ponding?	N/A	N/A	Gutter Slope (%)	N/A
N/A	Gutter Lip Ht (in)	N/A	N/A	Gutter X Slope (%)	N/A
N/A	Painted X Walk1?	No	N/A	Painted X Walk2?	N/A
	X Walk 1 Direction	To E		X Walk 2 Direction	N/A
N/A	X Walk 1 Width (in)	N/A	N/A	X Walk 2 Width (in)	N/A
	X Walk 1 Slope (%)	4.1		X Walk 2 Slope (%)	N/A
	X Walk 1 X Slope (%)	0.2		X Walk 2 X Slope (%)	N/A

N/A	Ramp inside XWalk1?	N/A	N/A	Ramp inside XWalk2?	N/A
	Road Slope (%)	N/A	N/A	Clear Space?	N/A
	Road X Slope (%)	N/A	N/A	Clear Space to XWalk (in)	N/A
N/A	Any Obstructions?	N/A	N/A	Storm Grate/Utility Hazard?	N/A
	Obstruction Type			Storm Grate/Utility Type	
		N/A			N/A
			Yes	Surface Condition? (G/P)	Good

Remove & Replace Entire Ramp.

Total Cost: \$ 1850.00
