Access Compliance Report

Public Rights-of-Way

(Curb Ramps)

Intersection ID: 15707	Main Street: DORCHESTER_PL	Cross Street: POINDEXTER_DR	Location: E
ADA ID: 99EA5555BDBB	Ramp Type: PerpDiag	Initial Pass/Fail: Fail	Overall Compliance: No
		Severity Score: 37.5

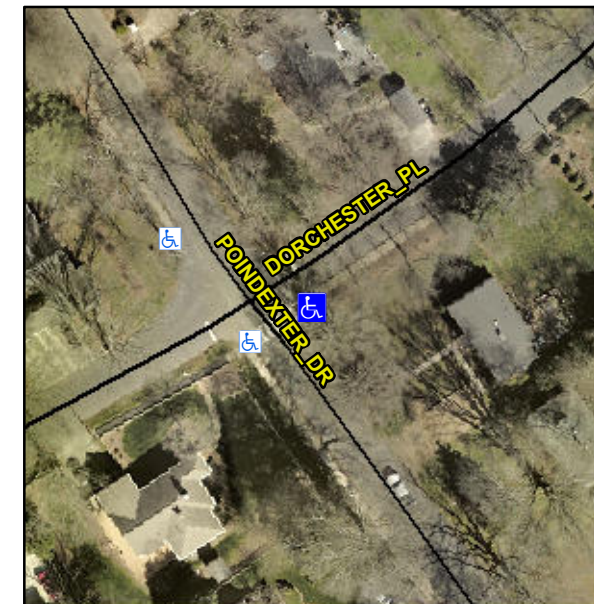
Not Found, R304.2.2, R304.5.3

Compliance	Description	Data	Compliance	Description	Data
N/A	Ramp Length (in)	51.0	No	Ramp Slope (%)	10.3
Yes	Ramp Width (in)	72.0	No	Ramp XSlope (%)	10.7
N/A	Flare Type LT	N/A	N/A	Flare Type RT	N/A
N/A	Flare Slope LT (%)	N/A	N/A	Flare Slope RT (%)	N/A
N/A	Flare Traversable LT?	N/A	N/A	Flare Traversable RT?	N/A
N/A	Landing Length (in)	N/A	N/A	DWS Provided?	N/A
N/A	Landing Width (in)	N/A	N/A	DWS Contrast?	N/A
N/A	Landing Slope (%)	N/A	N/A	DWS Length (in)	N/A
N/A	Landing X Slope (%)	N/A	N/A	DWS Full Width?	N/A
N/A	Landing Curb? (Y/N)	N/A	N/A	DWS Offset (in)	N/A
N/A	Shared Landing?	N/A			
N/A	Gutter Ponding?	N/A	N/A	Gutter Slope (%)	N/A
N/A	Gutter Lip Ht (in)	N/A	N/A	Gutter X Slope (%)	N/A
N/A	Painted X Walk1?	No	N/A	Painted X Walk2?	Yes
	X Walk 1 Direction	To NW		X Walk 2 Direction	To SW
N/A	X Walk 1 Width (in)	N/A	N/A	X Walk 2 Width (in)	82.5
	X Walk 1 Slope (%)	0.4		X Walk 2 Slope (%)	8.3
	X Walk 1 X Slope (%)	4.8		X Walk 2 X Slope (%)	1.3

N/A	Ramp inside XWalk1?	N/A	N/A	Ramp inside XWalk2?	Yes
	Road Slope (%)	4.0	N/A	Clear Space?	N/A
	Road X Slope (%)	8.6	N/A	Clear Space to XWalk (in)	N/A
N/A	Any Obstructions?	N/A	N/A	Storm Grate/Utility Hazard?	N/A
	Obstruction Type			Storm Grate/Utility Type	
		N/A			N/A
		Yes		Surface Condition? (G/P)	Good

Possible Solutions:

Remove & Replace Curb Ramp With Two New Directional Ramps or Equivalent.
