# Access Compliance Report

## Public Rights-of-Way (Curb Ramps)

| Intersection ID: 52311 | Main Street: IMPATIEN_DR | Cross Street: LUPINE_CT | Location: SE |
| ADA ID: 99EC3F9F89F7 | Ramp Type: PerpDiag | Initial Pass/Fail: Fail | Overall Compliance: No |

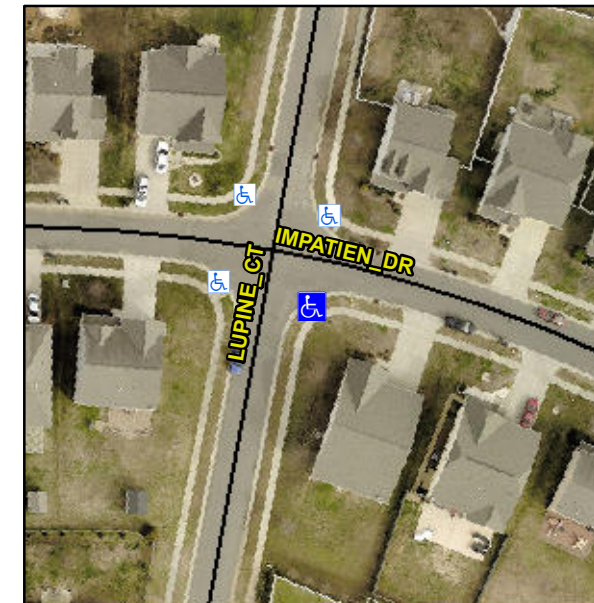
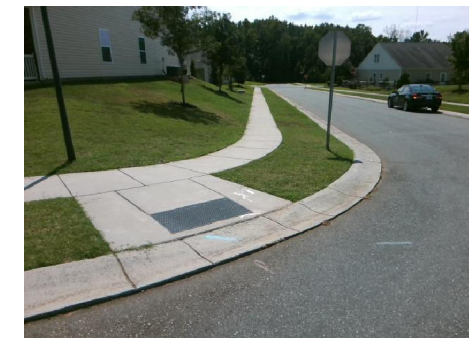
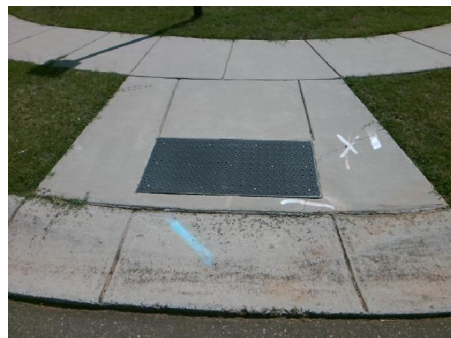
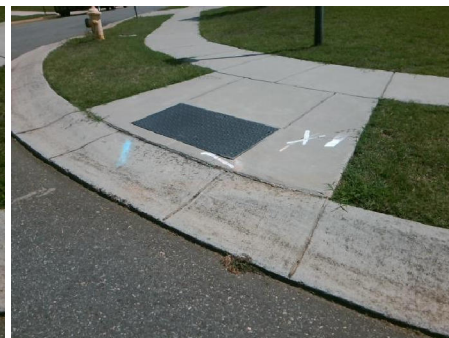
**Not Found, R304.5.1, R304.5.3**

| Compliance | Description | Data | Compliance | Description | Data |
|---|---|---|---|---|---|
| N/A | Ramp Length (in) | 70.0 | Yes | Ramp Slope (%) | 6.2 |
| No | Ramp Width (in) | 47.0 | No | Ramp XSlope (%) | 5.6 |

**Remove & Replace Curb Ramp With Two New Directional Ramps or Equivalent.**
