Access Compliance Report

Public Rights-of-Way

(Curb Ramps)

Intersection ID: 27418	Main Street: BALLANTYNE_COMMONS_PY	Cross Street: BALLANTYNE_TRACE_CT	Location: NE
ADA ID: 99F2FDD70F8C	Ramp Type: Perp	Initial Pass/Fail: Fail	Overall Compliance: No
Severity Score: 33.75			
Codes/Mitigation Info/Possible Solution		Field Measurements/Component Compliance

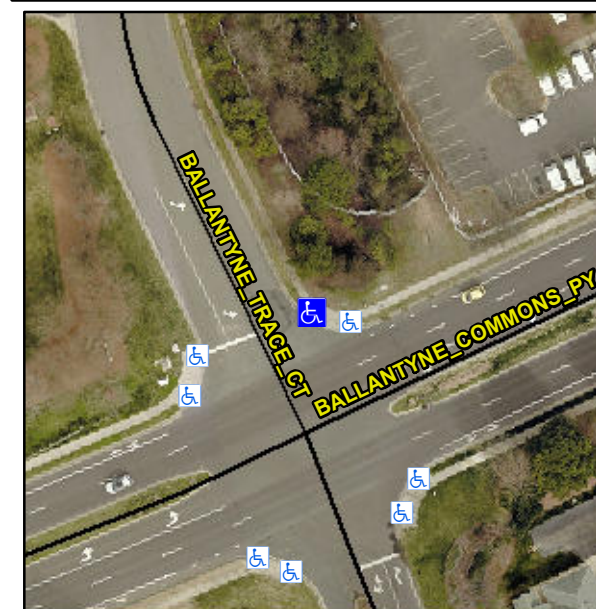
Not Found, R304.5.1, R304.5.3

Compliance	Description	Data	Compliance	Description	Data
N/A	Ramp Length (in)	96.0	Yes	Ramp Slope (%)	7.6
No	Ramp Width (in)	47.5	No	Ramp XSlope (%)	10.1
N/A	Flare Type LT	N/A	N/A	Flare Type RT	N/A
N/A	Flare Slope LT (%)	N/A	N/A	Flare Slope RT (%)	N/A
N/A	Flare Traversable LT?	N/A	N/A	Flare Traversable RT?	N/A
N/A	Landing Length (in)	N/A	N/A	DWS Provided?	N/A
N/A	Landing Width (in)	N/A	N/A	DWS Contrast?	N/A
N/A	Landing Slope (%)	N/A	N/A	DWS Length (in)	N/A
N/A	Landing X Slope (%)	N/A	N/A	DWS Full Width?	N/A
N/A	Landing Curb? (Y/N)	N/A	N/A	DWS Offset (in)	N/A
N/A	Shared Landing?	N/A			
N/A	Gutter Ponding?	N/A	N/A	Gutter Slope (%)	N/A
N/A	Gutter Lip Ht (in)	N/A	N/A	Gutter X Slope (%)	N/A
N/A	Painted X Walk1?	No	N/A	Painted X Walk2?	N/A
	X Walk 1 Direction	To SW		X Walk 2 Direction	N/A
N/A	X Walk 1 Width (in)	N/A	N/A	X Walk 2 Width (in)	N/A
	X Walk 1 Slope (%)	0.3		X Walk 2 Slope (%)	N/A
	X Walk 1 X Slope (%)	7.8		X Walk 2 X Slope (%)	N/A

N/A	Ramp inside XWalk1?	N/A	N/A	Ramp inside XWalk2?	N/A
	Road Slope (%)	N/A	N/A	Clear Space?	N/A
	Road X Slope (%)	N/A	N/A	Clear Space to XWalk (in)	N/A
N/A	Any Obstructions?	N/A	N/A	Storm Grate/Utility Hazard?	N/A
	Obstruction Type			Storm Grate/Utility Type	
		N/A			N/A
			Yes	Surface Condition? (G/P)	Good

Possible Solutions:

Remove & Replace Entire Ramp.
