# Access Compliance Report

## Public Rights-of-Way

| Intersection ID: 21031 | Main Street: CARMEL_RD | Cross Street: CROOKED_OAK_LN | Location: SE |
| ADA ID: 9A041ACC151B | Ramp Type: BlendTrans2 | Initial Pass/Fail: Fail | Overall Compliance: No |

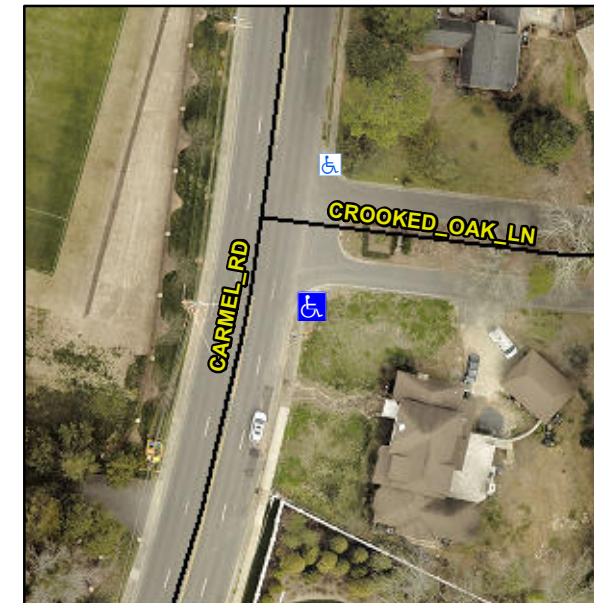
| | | Severity Score: 25 | |

**Not Found, R304.5.3**

| Compliance | Description | Data | Compliance | Description | Data |
|---|---|---|---|---|---|
| Yes | Ramp Width (in) | 48.0 | No | BlendTrans XSlope (%) | 7.8 |
| | | | No | Curb Slope (%) | 21.5 |

**Remove & Replace Curb Ramp With Two New Directional Ramps or Equivalent.**

Total Cost: \$ 3200.00
