# Access Compliance Report

## Public Rights-of-Way

### (Curb Ramps)

Intersection ID: 54374	Main Street: GRIER_RD	Cross Street: OLD_CONCORD_RD	Location: E
ADA ID: 9A068604A9F8	Ramp Type: Perp	Initial Pass/Fail: Fail	Overall Compliance: No
Severity Score: 8.75			
Codes/Mitigation Info/Possible Solution		Field Measurements/Component Compliance

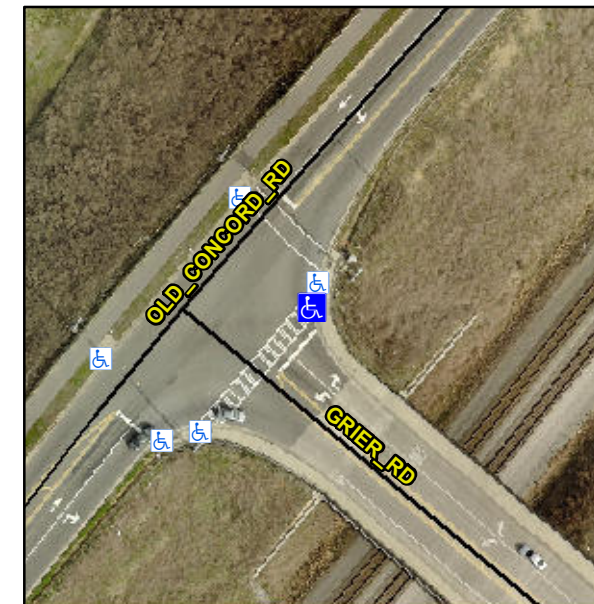
**Not Found, R304.5.1**

Compliance	Description	Data	Compliance	Description	Data
N/A	Ramp Length (in)	82.5	Yes	Ramp Slope (%)	6.4
No	Ramp Width (in)	46.5	Yes	Ramp XSlope (%)	1.0
N/A	Flare Type LT	N/A	N/A	Flare Type RT	N/A
N/A	Flare Slope LT (%)	N/A	N/A	Flare Slope RT (%)	N/A
N/A	Flare Traversable LT?	N/A	N/A	Flare Traversable RT?	N/A
N/A	Landing Length (in)	N/A	N/A	DWS Provided?	N/A
N/A	Landing Width (in)	N/A	N/A	DWS Contrast?	N/A
N/A	Landing Slope (%)	N/A	N/A	DWS Length (in)	N/A
N/A	Landing X Slope (%)	N/A	N/A	DWS Full Width?	N/A
N/A	Landing Curb? (Y/N)	N/A	N/A	DWS Offset (in)	N/A
N/A	Shared Landing?	N/A			
N/A	Gutter Ponding?	N/A	N/A	Gutter Slope (%)	N/A
N/A	Gutter Lip Ht (in)	N/A	N/A	Gutter X Slope (%)	N/A
N/A	Painted X Walk1?	Yes	N/A	Painted X Walk2?	N/A
	X Walk 1 Direction	To SW		X Walk 2 Direction	N/A
N/A	X Walk 1 Width (in)	103.5	N/A	X Walk 2 Width (in)	N/A
	X Walk 1 Slope (%)	0.3		X Walk 2 Slope (%)	N/A
	X Walk 1 X Slope (%)	1.1		X Walk 2 X Slope (%)	N/A

N/A	Ramp inside XWalk1?	Yes	N/A	Ramp inside XWalk2?	N/A
	Road Slope (%)	N/A	N/A	Clear Space?	N/A
	Road X Slope (%)	N/A	N/A	Clear Space to XWalk (in)	N/A
N/A	Any Obstructions?	N/A	N/A	Storm Grate/Utility Hazard?	N/A
	Obstruction Type			Storm Grate/Utility Type	
		N/A			N/A
		Yes		Surface Condition? (G/P)	Good

Possible Solutions:

**Remove & Replace Entire Ramp.**
