# Access Compliance Report

## Public Rights-of-Way

| Intersection ID: 16483 | Main Street: QUEENS_RD | Cross Street: RADCLIFFE_AV | Location: NE |
| ADA ID: 9A14B78CD262 | Ramp Type: PerpDiag | Initial Pass/Fail: Fail | Overall Compliance: No |

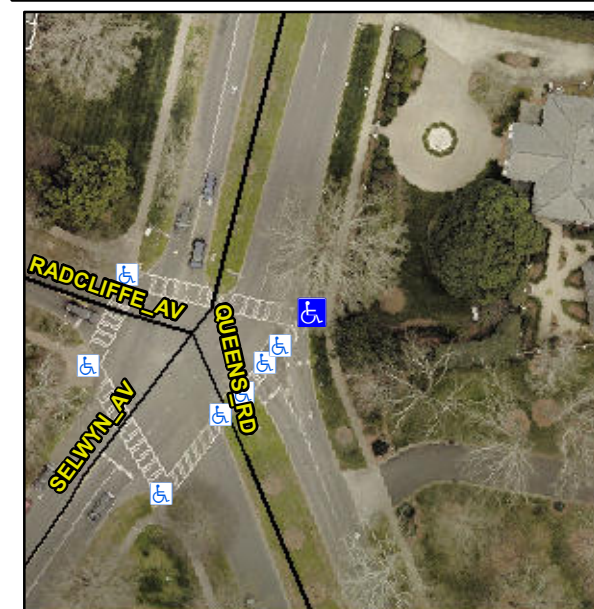
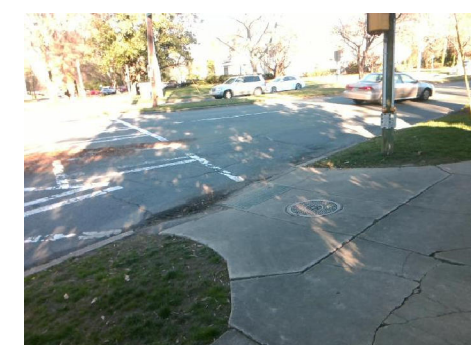
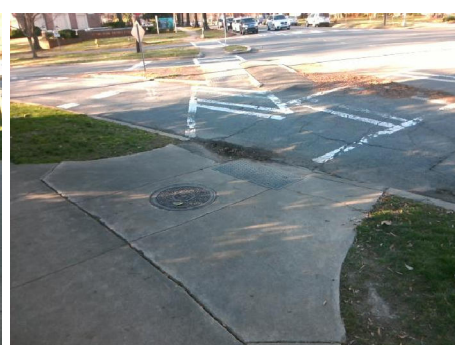
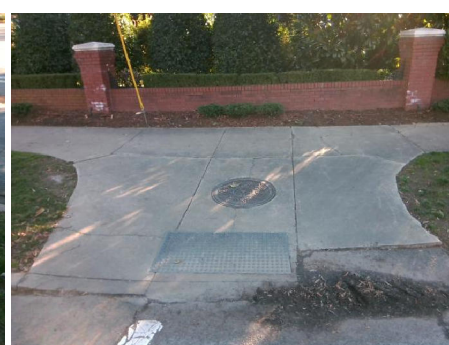
**Not Found, R304.2.2, R304.5.3**

| Compliance | Description | Data | Compliance | Description | Data |
|---|---|---|---|---|---|
| N/A | Ramp Length (in) | 103.5 | No | Ramp Slope (%) | 11.3 |
| Yes | Ramp Width (in) | 49.0 | No | Ramp XSlope (%) | 2.1 |

**Remove & Replace Curb Ramp With Two New Directional Ramps or Equivalent.**
