# Access Compliance Report

## Public Rights-of-Way

### (Curb Ramps)

Intersection ID: 44404	Main Street: FLOUFISHER_CT	Cross Street: BOBHOUSE_DR	Location:	SW
ADA ID: 9A1B3367D1A2	Ramp Type: PerpDiag	Initial Pass/Fail: Fail	Overall Compliance: No	Severity Score: 30
Codes/Mitigation Info/Possible Solution		Field Measurements/Component Compliance

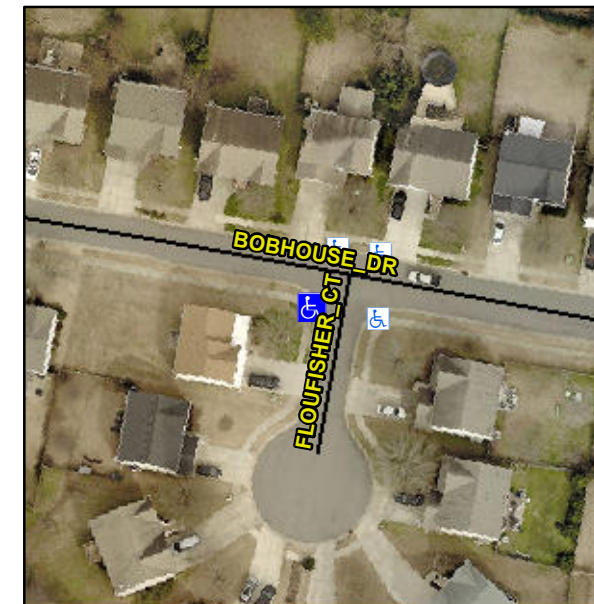
**Not Found, R304.5.1, R304.5.3**

Compliance	Description	Data	Compliance	Description	Data
N/A	Ramp Length (in)	48.0	Yes	Ramp Slope (%)	6.6
No	Ramp Width (in)	34.0	No	Ramp XSlope (%)	5.5
N/A	Flare Type LT	N/A	N/A	Flare Type RT	N/A
N/A	Flare Slope LT (%)	N/A	N/A	Flare Slope RT (%)	N/A
N/A	Flare Traversable LT?	N/A	N/A	Flare Traversable RT?	N/A
N/A	Landing Length (in)	N/A	N/A	DWS Provided?	N/A
N/A	Landing Width (in)	N/A	N/A	DWS Contrast?	N/A
N/A	Landing Slope (%)	N/A	N/A	DWS Length (in)	N/A
N/A	Landing X Slope (%)	N/A	N/A	DWS Full Width?	N/A
N/A	Landing Curb? (Y/N)	N/A	N/A	DWS Offset (in)	N/A
N/A	Shared Landing?	N/A			
N/A	Gutter Ponding?	N/A	N/A	Gutter Slope (%)	N/A
N/A	Gutter Lip Ht (in)	N/A	N/A	Gutter X Slope (%)	N/A
N/A	Painted X Walk1?	No	N/A	Painted X Walk2?	No
	X Walk 1 Direction	To NE		X Walk 2 Direction	To NW
N/A	X Walk 1 Width (in)	N/A	N/A	X Walk 2 Width (in)	N/A
	X Walk 1 Slope (%)	0.5		X Walk 2 Slope (%)	0.6
	X Walk 1 X Slope (%)	2.8		X Walk 2 X Slope (%)	1.9

N/A	Ramp inside XWalk1?	N/A	N/A	Ramp inside XWalk2?	N/A
	Road Slope (%)	2.8	N/A	Clear Space?	N/A
	Road X Slope (%)	3.4	N/A	Clear Space to XWalk (in)	N/A
N/A	Any Obstructions?	N/A	N/A	Storm Grate/Utility Hazard?	N/A
	Obstruction Type			Storm Grate/Utility Type	
		N/A			N/A
		Yes		Surface Condition? (G/P)	Good

**Remove & Replace Curb Ramp With Two New Directional Ramps or Equivalent.**

Total Cost: \$ 3200.00
